**CITY OF WASHOUGAL  
CITY COUNCIL WORKSHOP AGENDA  
Monday, November 7, 2022  
5:00 PM**

CWFD Capital Facilities Plan & Fire Impact Fee Update

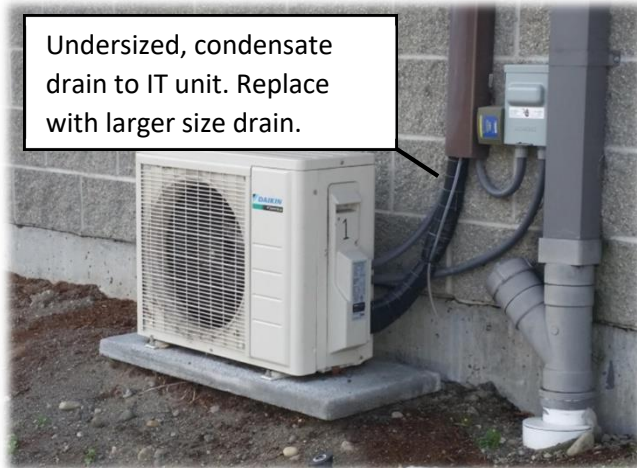
Undersized, condensate drain to IT unit. Replace with larger size drain.

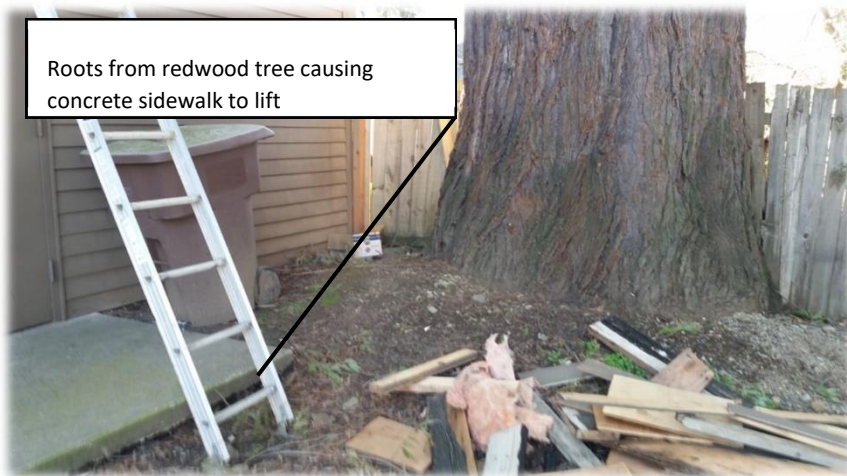
- Asphalt Paving –fair condition
- Parking Shared parking lot with City Hall
- Stormwater – none
- Lighting recessed soffit lighting
- Landscape very large redwood tree near NW building corner. Roots from tree have lifted concrete sidewalk and may damage concrete foundation over time. Large limbs falling from this tree will damage roof and create a life safety hazard.

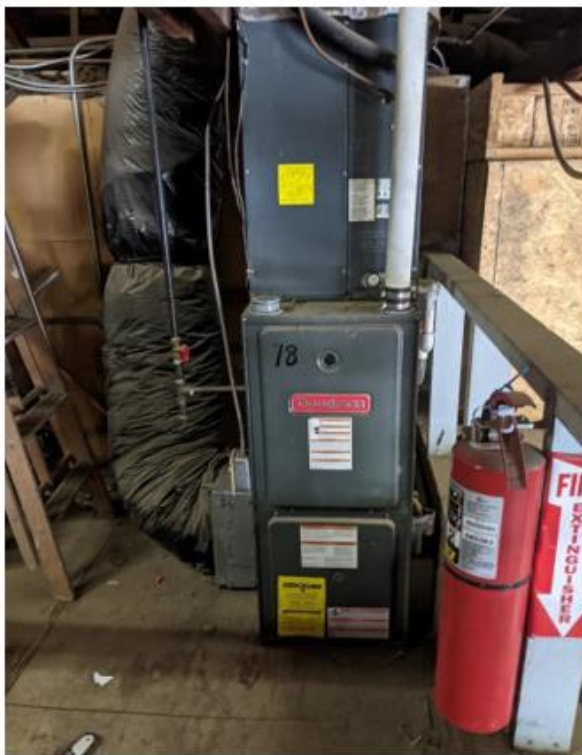
Figure 4.4. Building A Workshop Furnace

The west side of the building has a mechanic's shop that is served by a second Goodman furnace that has a 3-ton Goodman heat pump from 2007 (see [Figure 4.4](#) and [Figure 4.5](#)). This heat pump is an R-22 unit and while not visibly failing is near the end of its expected service life (15-20 years per ASHRAE) and planning should include replacing this unit soon.

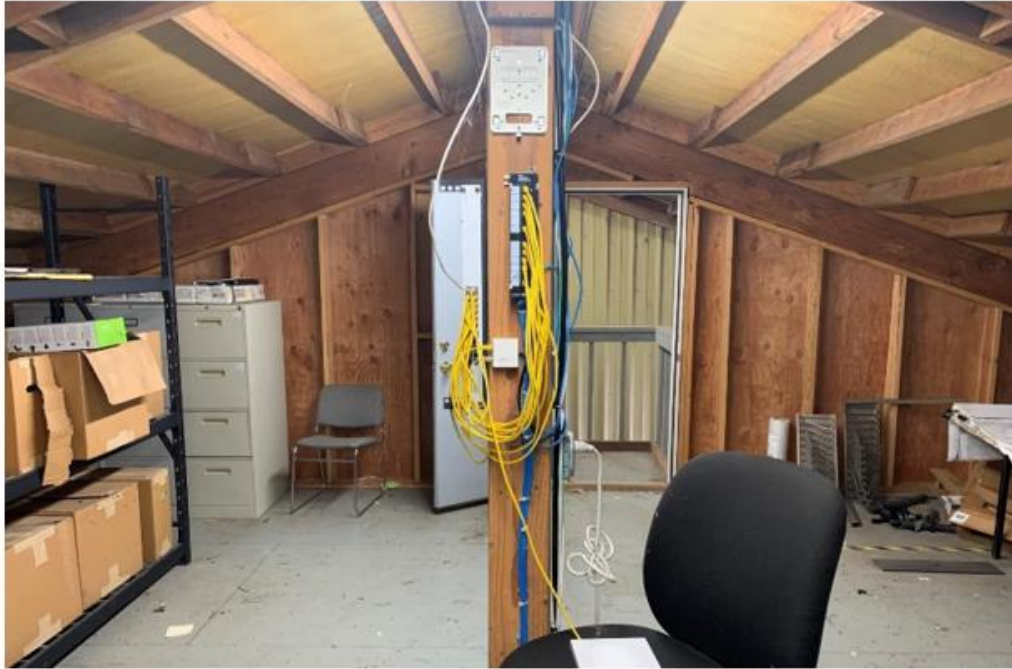
**Figure 3.6. Networking hardware in Loft**

Networking hardware is installed in the loft, as shown in [Figure 3.6](#). It is recommended that this equipment be installed in a dedicated space, such as a communication closet, or be installed in an enclosure for protection. Some of the communication cables located in the loft space are loosely installed without adequate structural support, as shown in [Figure 3.7](#).

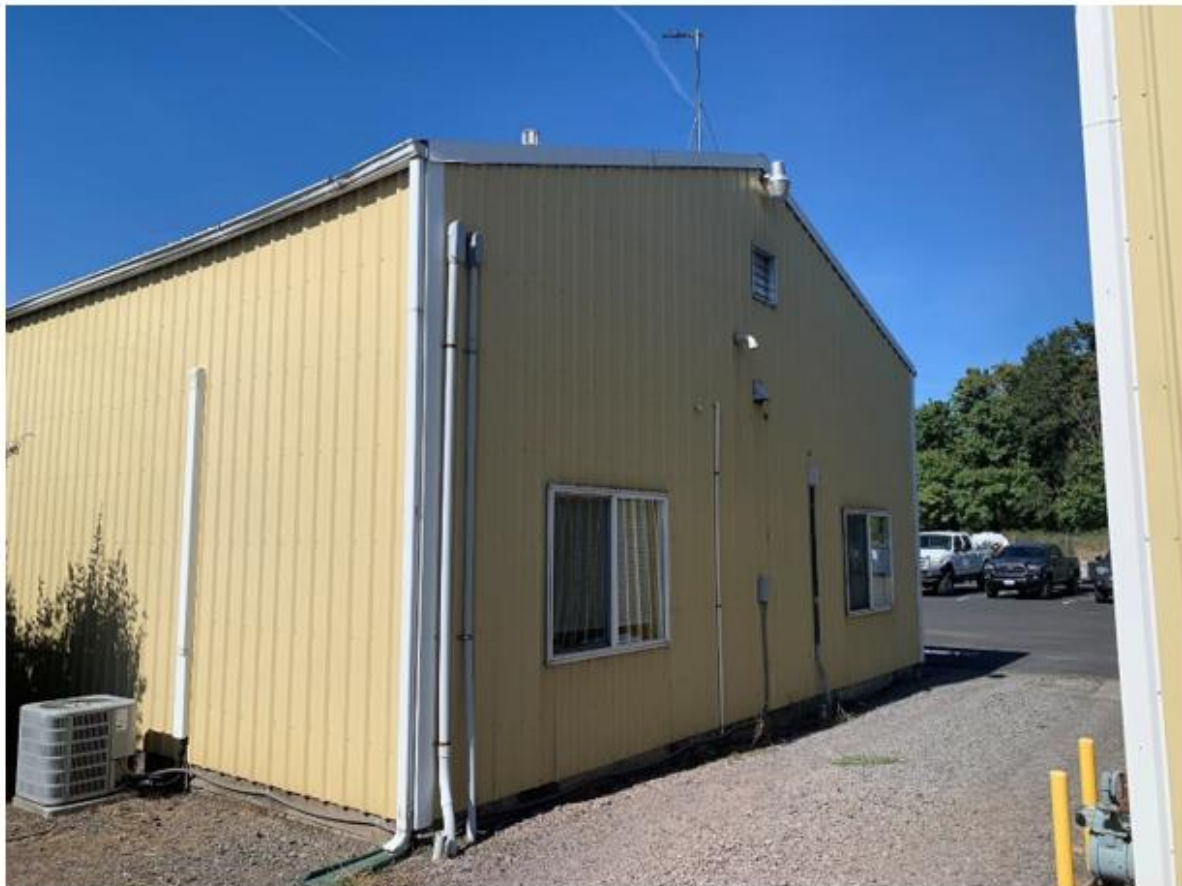
**Figure 3.8. HVAC Unit and Disconnect Switch**

An HVAC unit is installed outdoors on the south side of the building, and the electrical disconnect switch for this unit is installed on the east side of the building, as shown in [Figure 3.8](#). Since the switch is not in sight of the HVAC unit, it is in violation of NEC requirements. A service outlet for the HVAC unit is also missing per NEC requirements.
