**CITY OF WASHOUGAL  
CITY COUNCIL WORKSHOP MEETING  
MINUTES  
Monday, November 7, 2022  
5:00 PM**

**A. City Manager's Office: 2022 Community Survey Results**

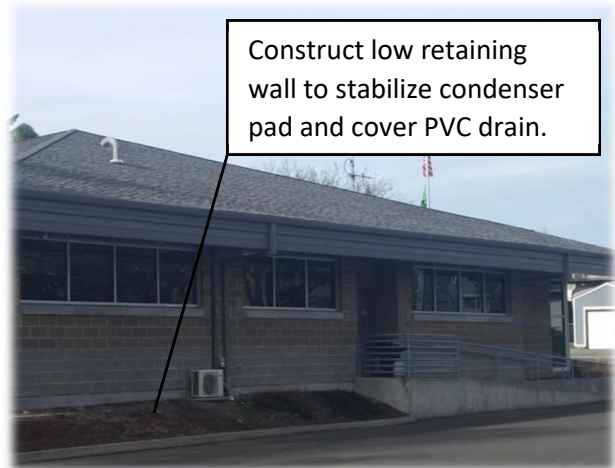
Undersized, condensate drain to IT unit. Replace with larger size drain.

Construct low retaining wall to stabilize condenser pad and cover PVC drain.

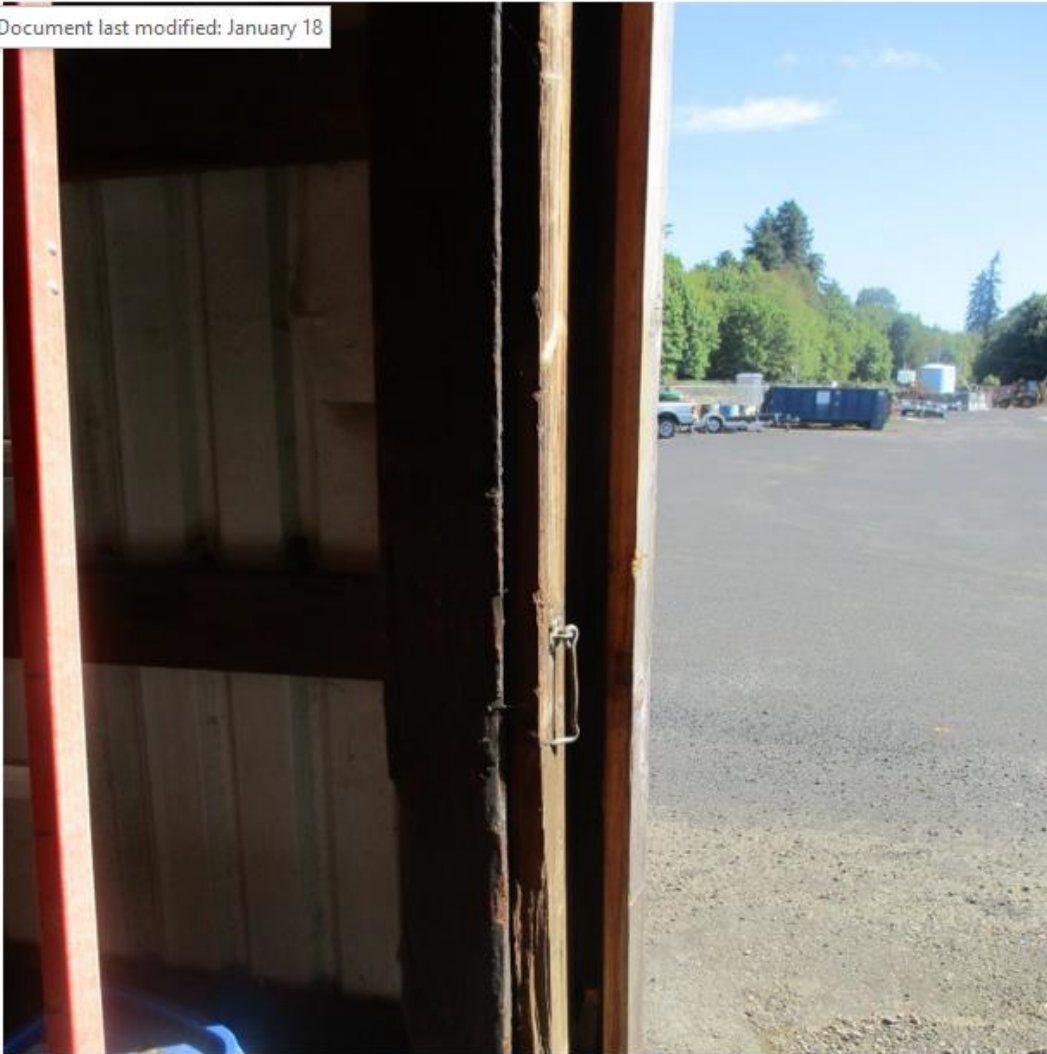
**Figure 2.5. Area Used for Storage**

The area above the main office space is accessible by a staircase in the gravel floor storage area. It appears this area is used for storage and mechanical equipment (see [Figure 2.5](#) and [Figure 2.6](#)). A sign is posted at the top of the stairs indicating a 20 psf load limit (see [Figure 2.7](#)). This meets the current code requirement for uninhabitable attic spaces with storage. Code defines this as uninhabitable due to the low head clearance. The floor exhibits some softness when walking around. No signs of distress are obvious. The deflection felt in the floor is likely due to the ceiling structure of the attic space not being adequately designed to limit deflection. Care should be taken to limit what is placed in this storage area so as not to exceed the load limitation.

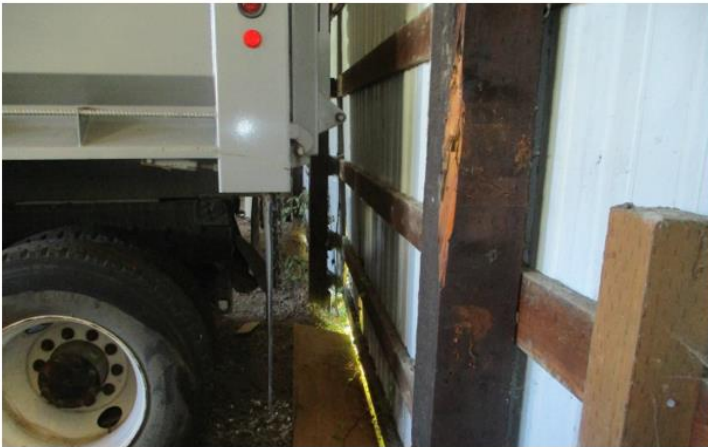
Figure 2.11. Column Damage

One column between the third and fourth bay shows damage due to vehicle impact, as shown in [Figure 2.11](#). No decay was noted in this, or any other, of the columns. Other than the damaged purlins in the third bay, all other purlins appear to be in good condition. No signs of decay are noted in the roof system, however with only the metal roofing to protect the members, the roof system is at a greater risk of getting wet and decaying over time.

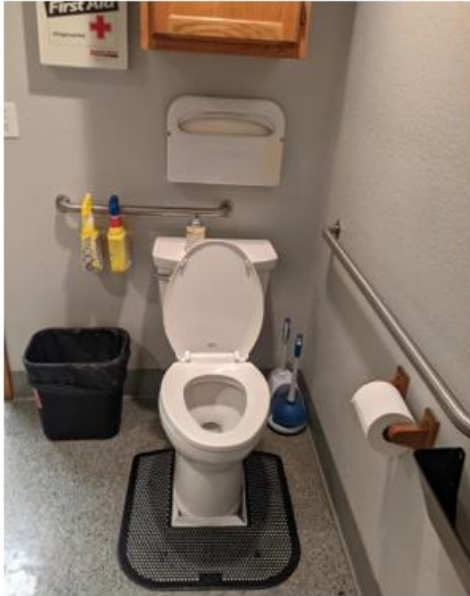
**Figure 4.11. Building C Water Closet**

The restroom has a shower, water closet, and service sink which is not ADA accessible, (see [Figure 4.11](#), [Figure 4.12](#), and [Figure 4.13](#)). A Bradford White natural gas water heater is in the attic (see [Figure 4.14](#)). This unit is dated 1993 per the Washington LNI Certificate of Inspection. There are signs of previous leaks in the drain pan below the unit and the unit is well beyond the expected life of 10 to 15 years. The plumbing piping was recently modified to serve a partially constructed new room in the back of the building using PEX piping; this new room is not complete and is not in compliance with the current codes. The natural gas meter is in fair condition showing some surface rust.
