**CITY OF WASHOUGAL  
CITY COUNCIL WORKSHOP AGENDA  
Monday, November 7, 2022  
5:00 PM**

CWFD Capital Facilities Plan & Fire Impact Fee Update

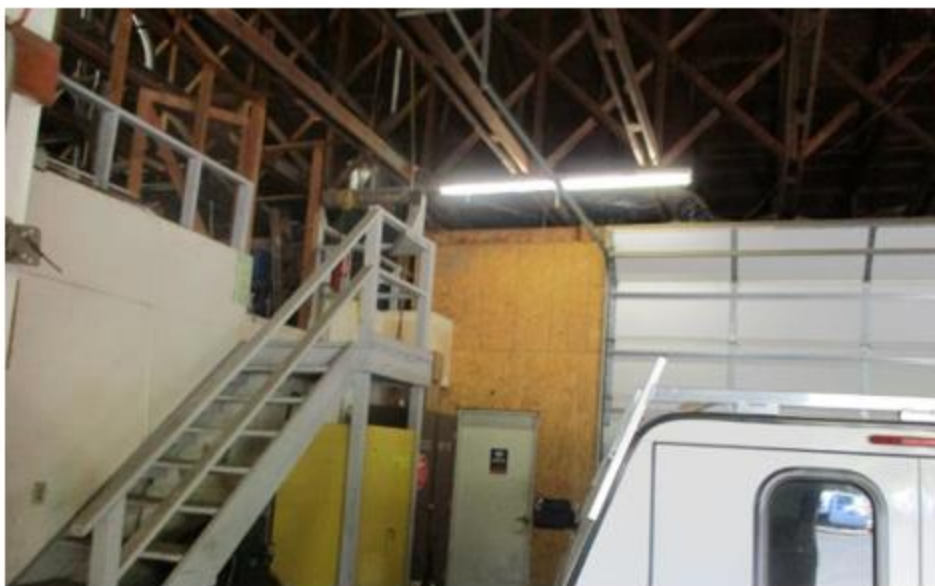
**Figure 2.5. Area Used for Storage**

The area above the main office space is accessible by a staircase in the gravel floor storage area. It appears this area is used for storage and mechanical equipment (see [Figure 2.5](#) and [Figure 2.6](#)). A sign is posted at the top of the stairs indicating a 20 psf load limit (see [Figure 2.7](#)). This meets the current code requirement for uninhabitable attic spaces with storage. Code defines this as uninhabitable due to the low head clearance. The floor exhibits some softness when walking around. No signs of distress are obvious. The deflection felt in the floor is likely due to the ceiling structure of the attic space not being adequately designed to limit deflection. Care should be taken to limit what is placed in this storage area so as not to exceed the load limitation.

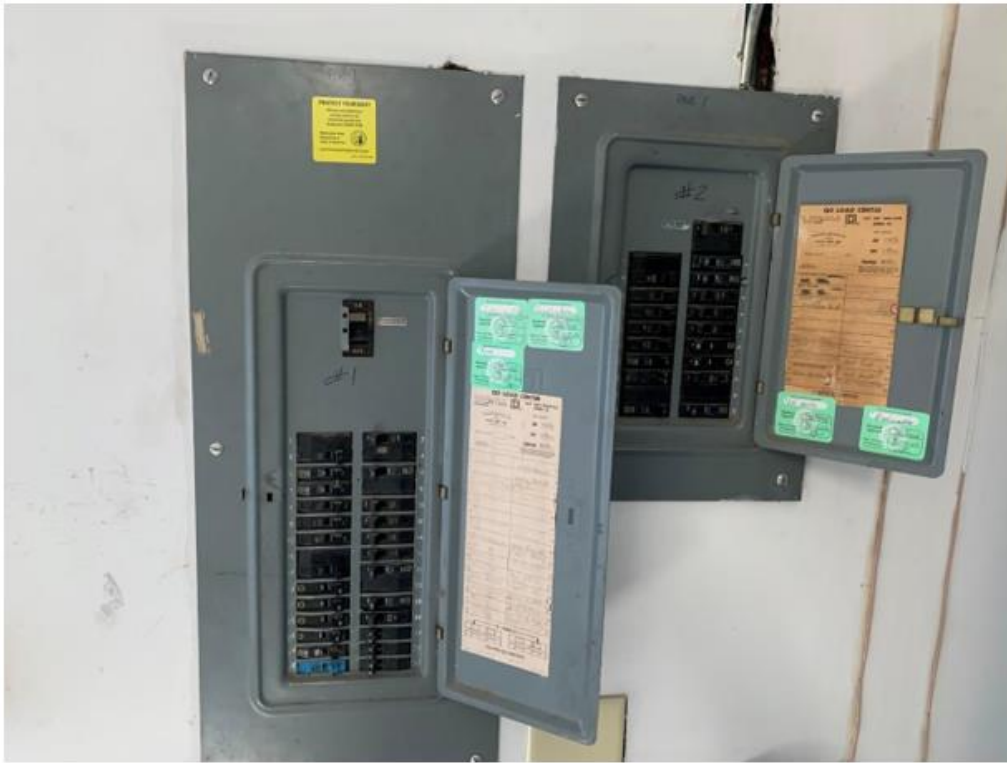
**Figure 3.1. Building A Panelboard**

Building A is provided with a 120/240-volt, 1-phase, 200-amp, electrical service via an overhead line from Clark PUD. The building includes a 200-amp main panelboard with 30 spaces and a 100-amp subpanel with 20 spaces, as shown in [Figure 3.1](#). Every circuit in these panels appears to be in use with no space for future loads. The panels are Square D QO load centers from the original construction. The panels appear to be in fair condition; however, replacement of these panels should be considered as they are beyond the end of the typical lifespan of 40 years. There is no standby power provided to the building.

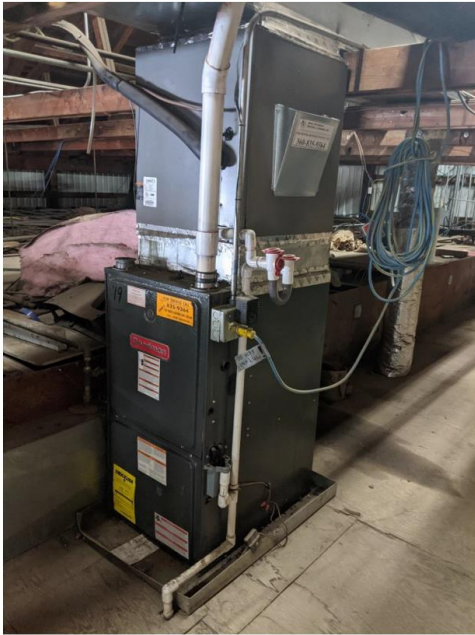
Figure 4.1. Building A Admin Furnace

This area is served by a residential style Goodman natural gas furnace with a 3.5-ton Lennox air conditioner (see [Figure 4.1](#) and [Figure 4.2](#)). The air conditioner was manufactured in 2015; it is unclear when the furnace was manufactured but assumed that it is the same age as the air conditioner and is in fair condition; although, there is a large air leak between the furnace section and the air conditioner coil (see [Figure 4.3](#)) that should be repaired to reclaim some of the system capacity within the occupied

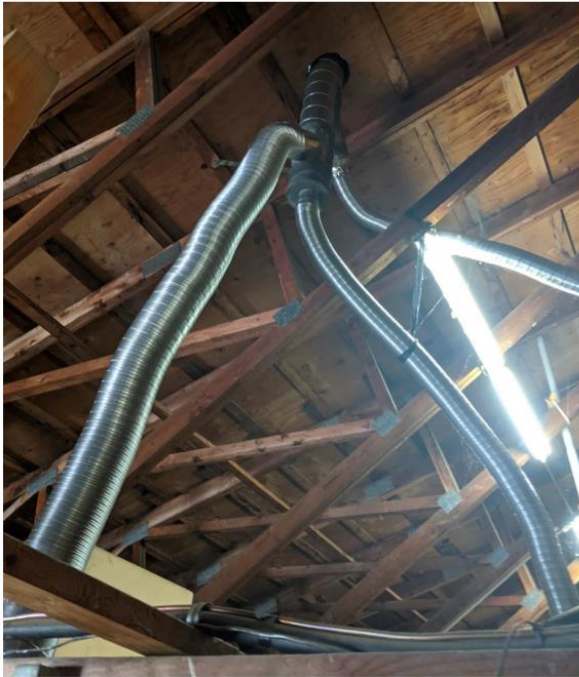
Figure 4.7. Building A Exhaust Connections

There are several exhaust systems connected into a single roof penetration (see [Figure 4.7](#)). None of these ducts are insulated and may have condensation issues since they are in the unheated portion of the building.

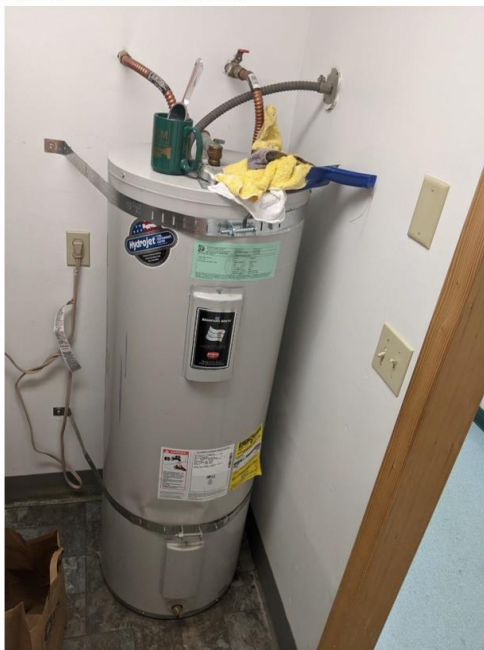
Figure 4.8. Building A Domestic Water Heater

Plumbing is limited to the break room and two restrooms in the administrative area. The restrooms appear to be in good condition and the fixtures were all working. A Bradford White electric domestic water heater from 2005 is in the alcove adjacent to the women's restroom (see [Figure 4.8](#)). This appears to be in working condition but is nearing the end of its expected service life and accommodations for replacement should be considered. There is also an ice maker in this space that appears to be in good working order.

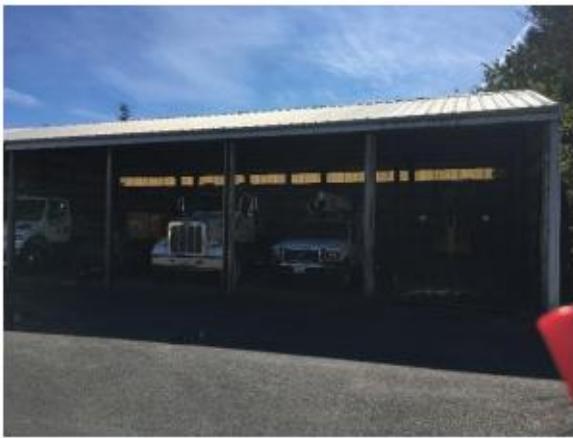
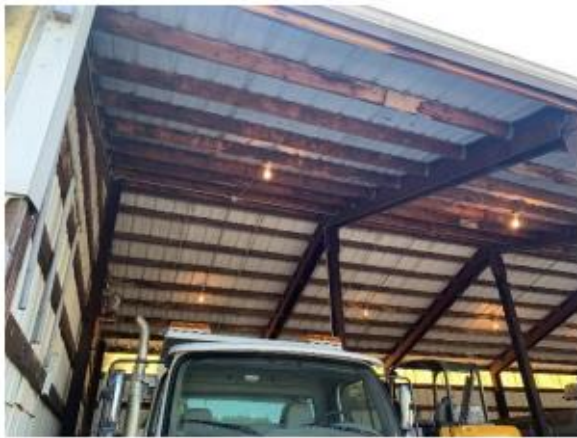
#### **Building B Exterior Photos**

- Metal roof and roof fascia system are in fair condition
- No obvious wear and tear marks on the roof were found
- Detached roof panels are noted near interface with Building C roof
- Leakage from the roof is expected

- Wall exterior condition is below average
- Finish of the wall panels are generally intact
- Multiple dents and locally deformed areas on metal panels are found
- Back wall panels and horizontal wall girts are detached and left opening at the back of the building caused by impact from vehicle
- Aged, corrugated fiberglass wall panels are in fair condition

- Wood fascia and wood blockings that support gutter systems are exposed and unprotected
- Downspouts are functioning
- Water may migrate from the back at the detached wall panels

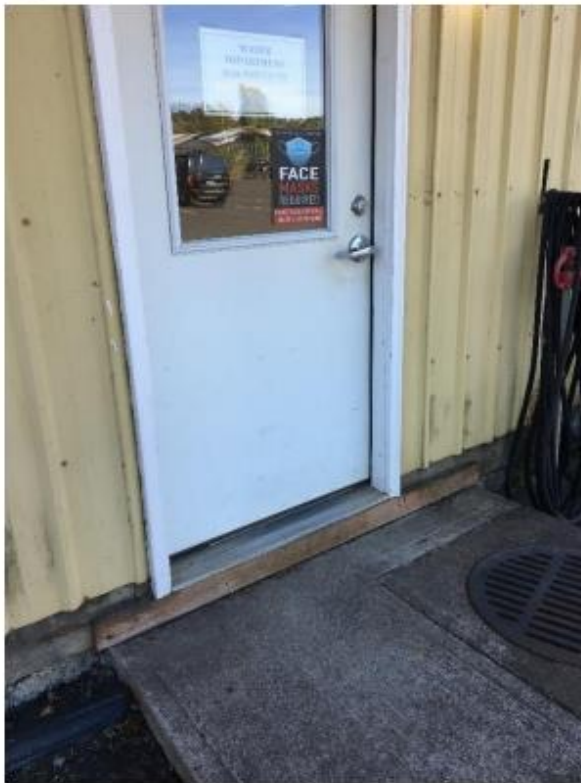
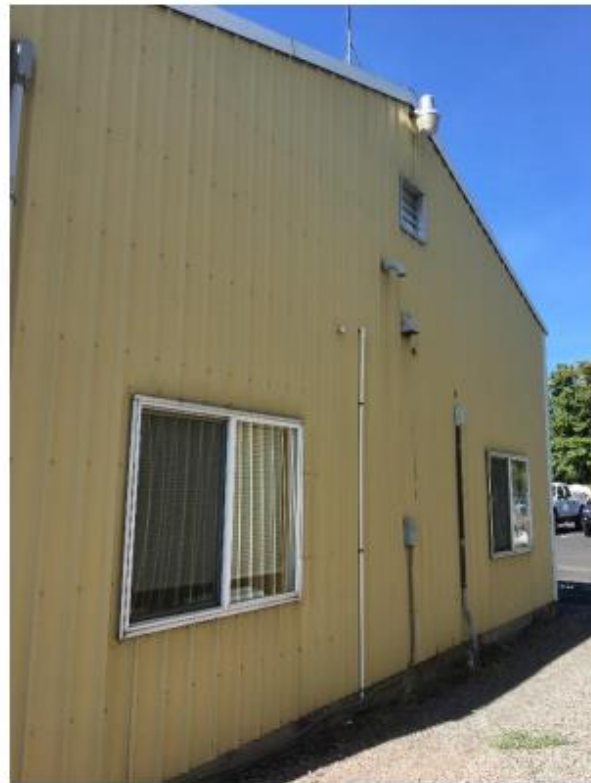
## Building C Exterior Photos

- Wall exterior condition is aged and below average
- Finish of the wall panels are generally intact
- Dents and locally deformed areas on metal panels were
- Treated wood wall curbs are exposed without flashing transition or protection

- Portion of the roof gutters is slightly deformed above the barn door at storage
- Wood fascia and wood blockings that support gutter systems are exposed and unprotected
- Downspouts are functioning
- Downspouts are not tied to the storm drain system and most of them are without splash block
- Oversize metal flashing and trim above vehicle access door to the shop is in fair condition. Metal flashings above windows function but are in poor condition.

- Double pane windows are provided at north and east walls, and they are in fair condition
- Water migration likely occurs at the windows due to poor flashing details. They function but are in bad condition.
- In-swing exterior egress door is not insulated
- Manual uninsulated sliding rolling door at garage is deformed but functioning. It is in poor condition.

The slab under the office space section is exposed at grade and does not have a turndown at the edges, which is required to ensure adequate frost depth (see [Figure 1.8. Building C Exterior Photos](#)). Frost depth at this location is 12 inches. It is likely that this slab was poured after the building was erected and does not work to provide structural support to the building. If frost damage to the slab were to occur, such as heaving, it could lead to damage to the floor finishes and partition walls.

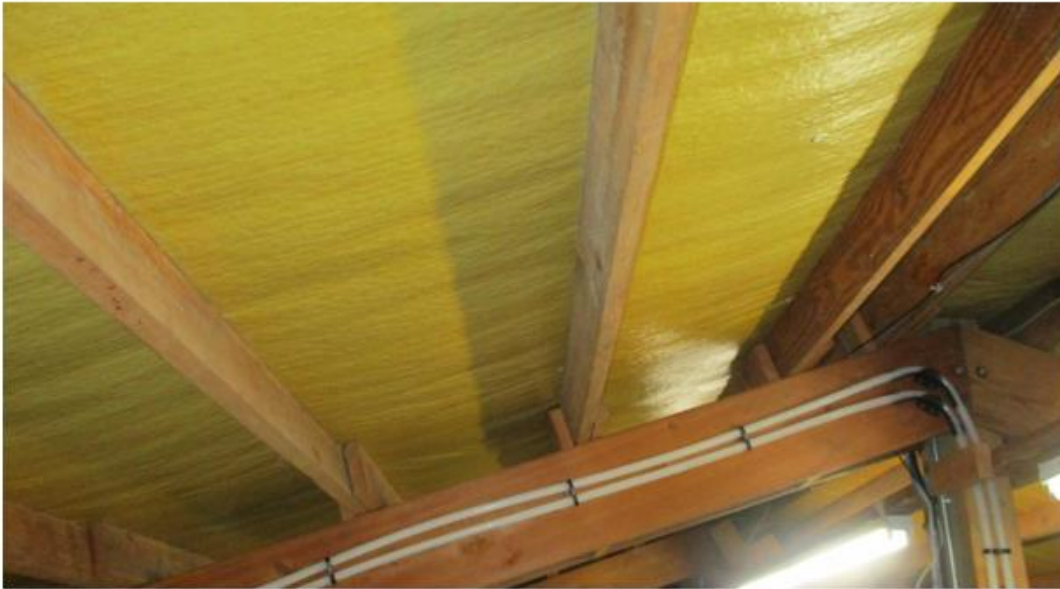
**Figure 2.14. Insulation**

Most of the structural elements are hidden from view by interior finishes, however, the portions of the structural framing that are visible from the loft area and in the storage area, appear to be in very good condition. The roof sheathing (if present) is hidden by insulation (see [Figure 2.14](#)). The joists supporting the loft area have had holes drilled in them for electrical wiring and plumbing (see [Figure 2.15](#)). These holes do not appear to be placed in compliance with best practices (away from ends, and away from top and bottom edges).

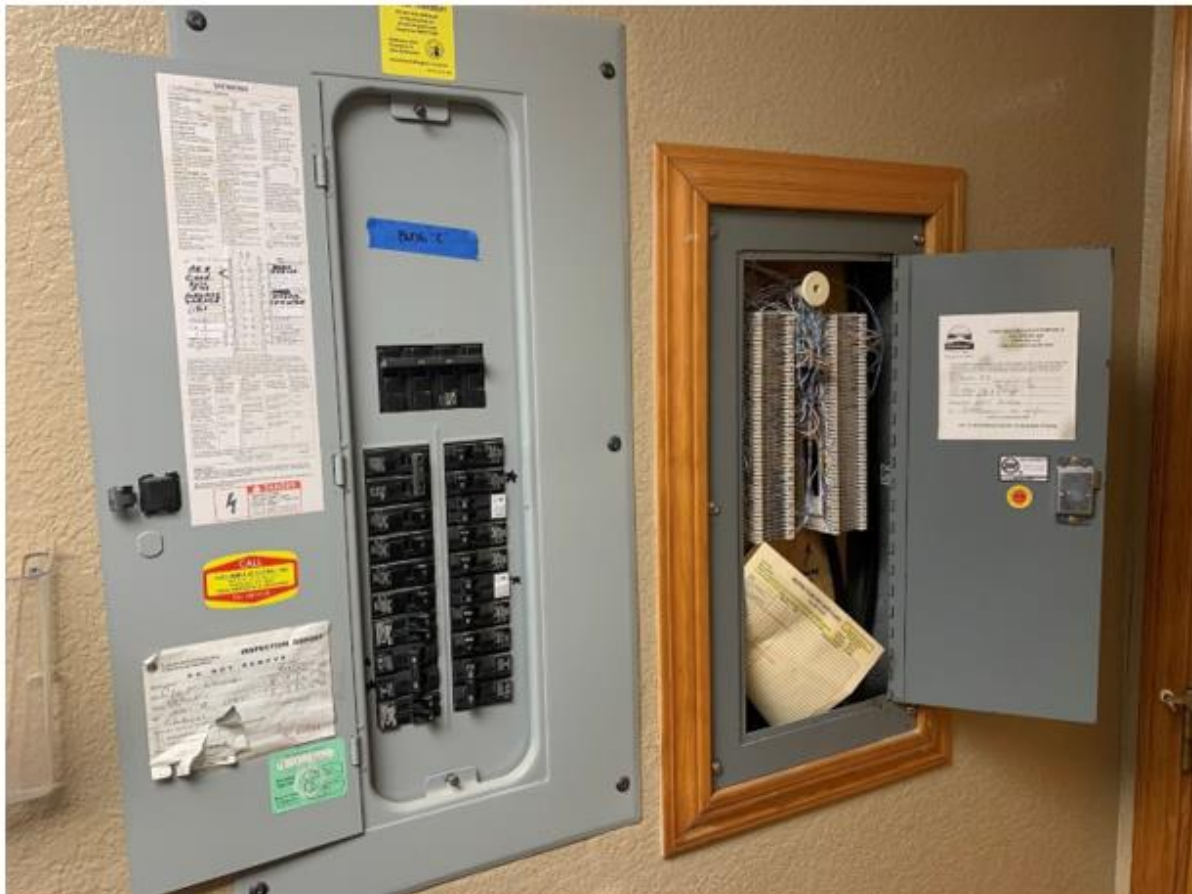
**Figure 3.5. Building C Panelboard**

Building C is provided with a 120/240-volt, 1-phase, 200-amp electrical service from Clark PUD. The building includes a 200-amp main panelboard with 20 spaces, as shown in [Figure 3.5](#). Every circuit in these panels appears to be in use with no space for future loads. The panel is a Siemens ITE load center and appears to be in good condition. There is no standby power provided to the building.

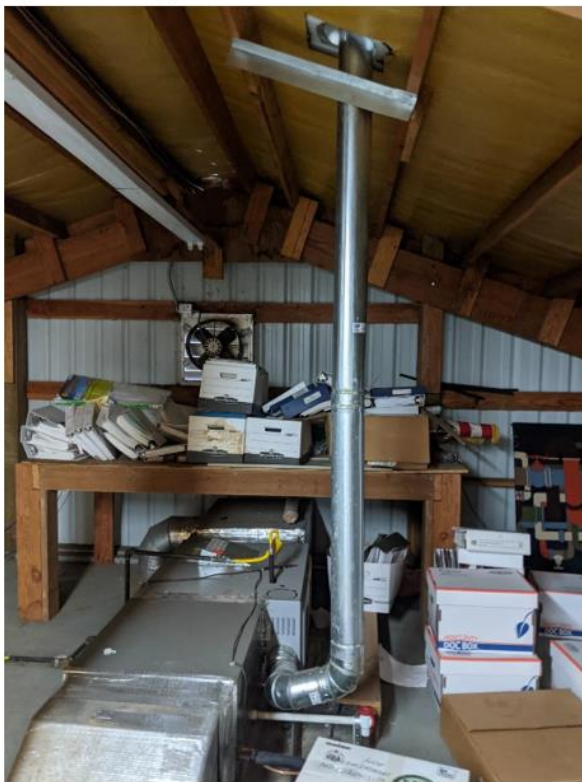
Figure 4.9. Building C Furnace

Building C has an HVAC and plumbing system serving the main level with equipment located in the attic (see [Figure 4.9](#)). A horizontal Lennox furnace is installed on the floor of the attic and an Aire-Flo (Lennox subsidiary) air conditioner is installed at the rear of the building (see [Figure 4.10](#)).

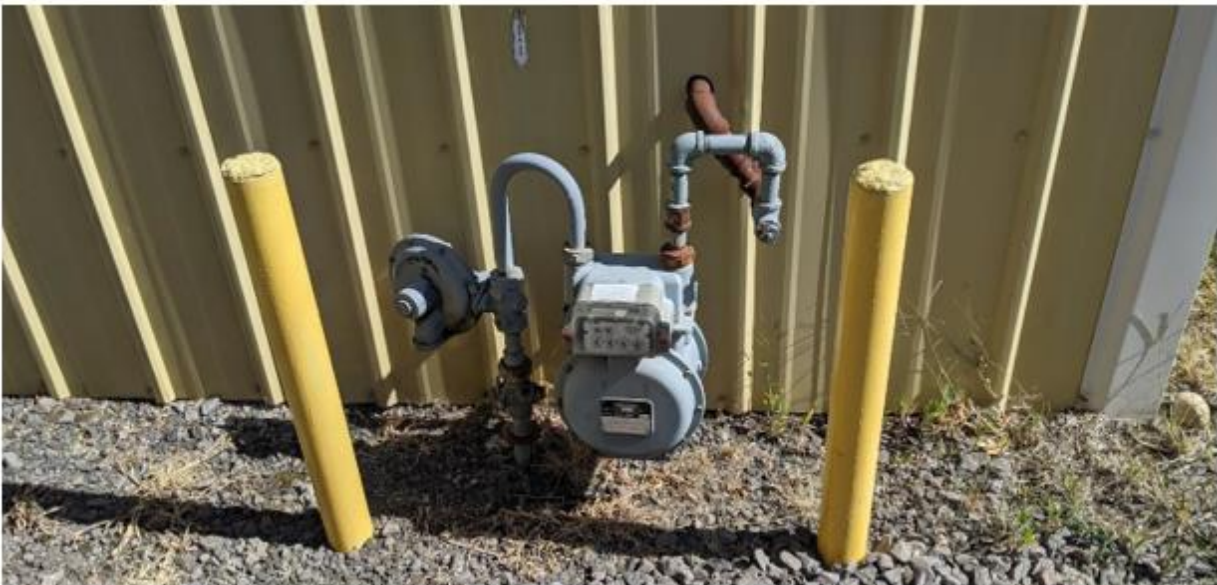
**Figure 4.16. Building D Natural Gas Meter**

The natural gas service is located in the narrow access road between buildings C and D but protected by bollards (see [Figure 4.16](#)).

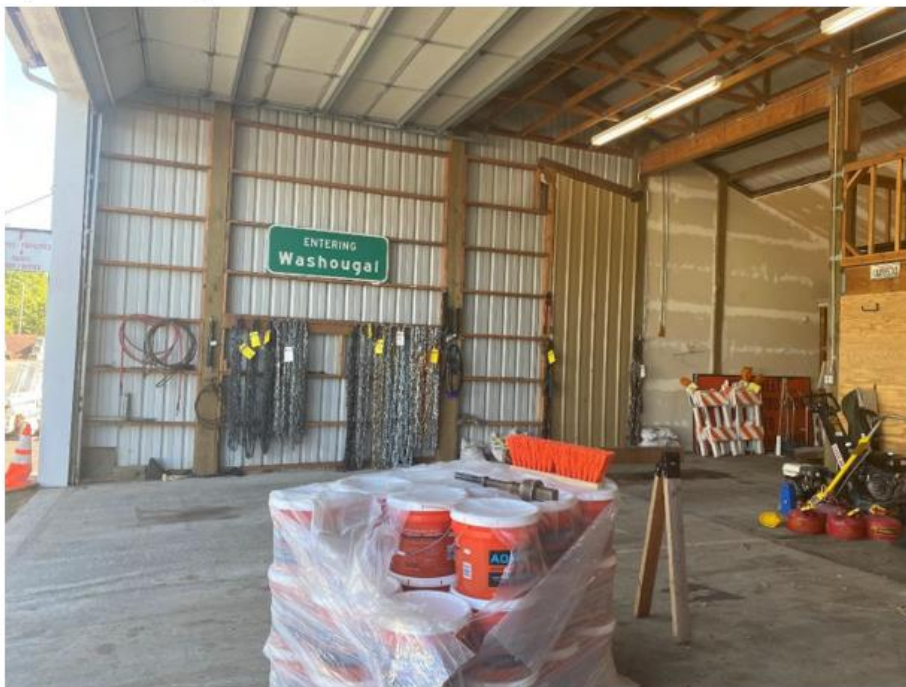
**Figure 2.18. Building E Structure**

Building E is a wood post frame building that is primarily used for general purpose storage with a concrete floor. It is unknown if the slab meets frost depth requirements. The roof is supported by wood trusses. The west wall is shared with Building D and the east wall is partially shared with Building F. In general, the exposed structure appears to be in good condition. Based on the construction methods used and the coloration of the treated timber elements, it appears this structure is one of the newer structures on the site. Photos are shown in [Figure 2.18](#) and [Figure 2.19](#).

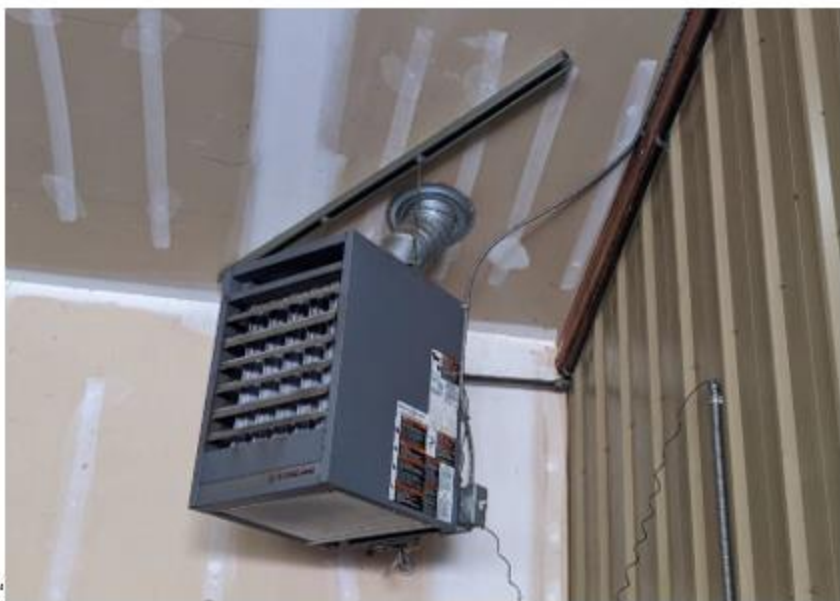
**Figure 4.17. Building E Unit Heater**

Building E has a single unit heater in the southwest corner, fed by natural gas from Building D (see [Figure 4.17](#)). The thermostat for this unit has been disassembled and may not be functioning (see [Figure 4.18](#)). There are visible gaps around the perimeter of this space, most noticeably at the joint between Building D and Building E that allow air and water to infiltrate the building. These gaps should be repaired to maximize heating system efficiency.

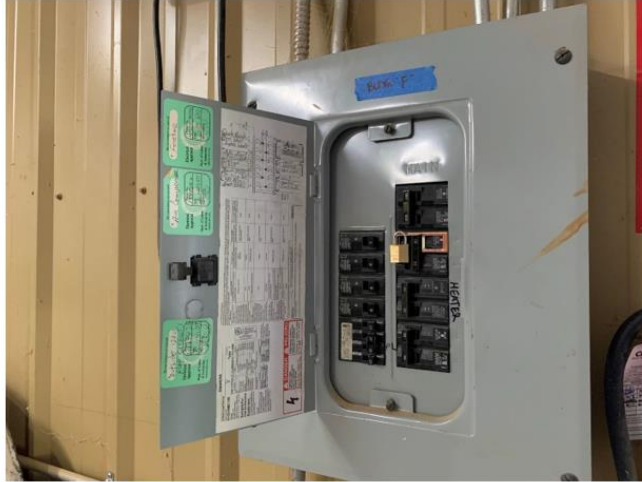
Figure 3.11. Building F Panel

Building F is provided with a 120/240-volt, 1-phase, 100-amp electrical sub panel. This building does not include a separate electrical service from Clark PUD. During the site visit it was undetermined where this panel is being fed from. The panel is a Siemens load center with 12 spaces, as shown in [Figure 3.11](#), and appears to be in good condition. A large amount of scrap materials is being stored in front of the panel, as shown in [Figure 3.12](#), which is in violation of NEC requirements for clear working space in front of electrical equipment.

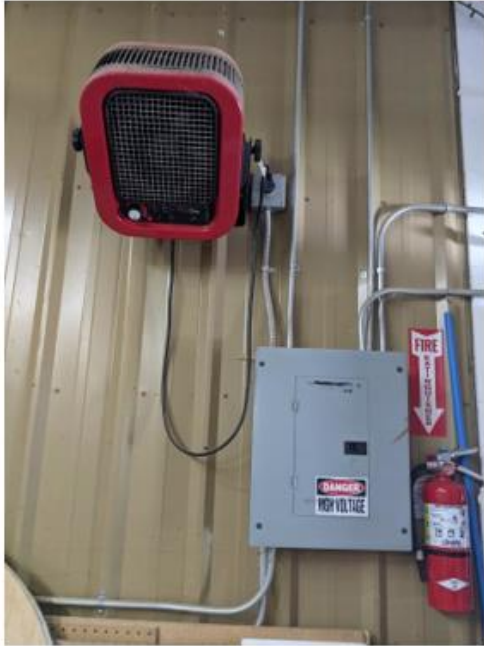
**Figure 4.19. Building F Electric Unit Heater in Entry Area Shop**

Building F, at the far east end of the row of buildings, has several different systems serving it. In the entry, there is an electric unit heater in the entry area shop (see [Figure 4.19](#)), and another in the shop and storage area (see [Figure 4.20](#)).

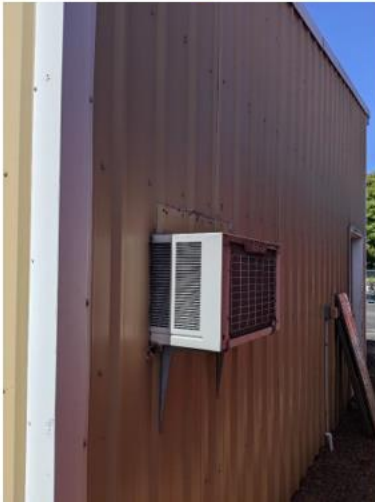
Figure 4.22. Building E A/C in Parks Office

Two wall-mounted air conditioners serve the entry area shop (see [Figure 4.21](#)), and the parks office in the southeast corner (see [Figure 4.22](#)). Neither unit is in use, and they are both blocked by stored items on the inside.

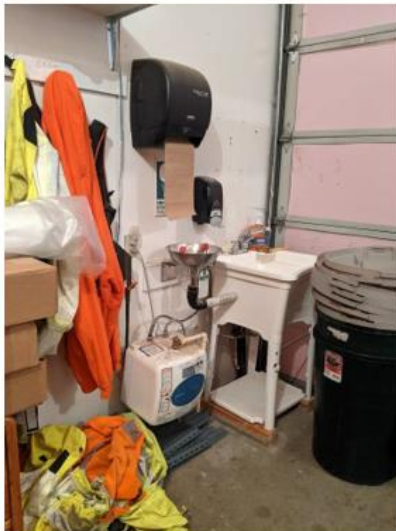
Figure 4.23. Building F Sink

A service sink in the shop and storage area has a small electric water heater serving a service sink (see [Figure 4.23](#)).

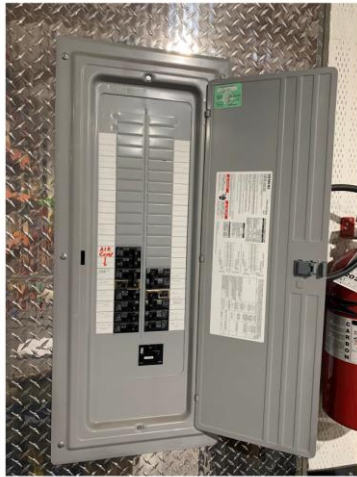
Figure 3.13. Building G Panel

Building A is provided with a 120/240-volt, 1-phase, 200-amp, electrical service via an overhead line from Clark PUD. The building includes a 200-amp main panelboard with 40 spaces, as shown in [Figure 3.13](#). The panelboard is in new condition and has many spaces available for expansion. There is no standby power provided to the building.

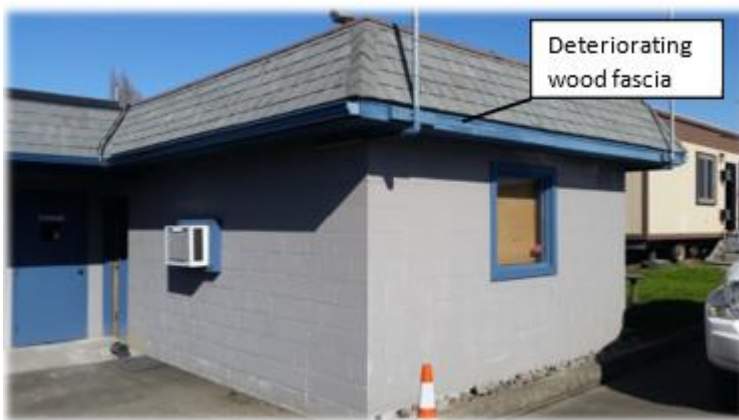
- Roof single ply membrane roof with asphalt shingle on mansard roof – in good condition
- Gutter & Downspouts Continuous metal gutters and downspouts – in fair condition
- Exterior Cladding CMU single wall construction. Wood fascia at South elevation is deteriorating and needs replacement

- The Public Works Wastewater building is a small, concrete block building that houses electrical switch gear, a wastewater lab, and office space for the wastewater department. The building is in good condition with a newer single ply membrane roof. However, the lack of insulation and outside air ventilation will result in high energy costs and poor indoor air quality.
- Suggest that consideration be given to constructing a code compliant office addition to the East and converting the existing office space to unheated storage.
- Lack of wall insulation results in high energy cost per square foot.
- Wood fascia at South elevation is decaying and needs replacement
