**CITY OF WASHOUGAL  
CITY COUNCIL WORKSHOP MEETING  
MINUTES  
Monday, November 7, 2022  
5:00 PM**

**A. City Manager's Office: 2022 Community Survey Results**

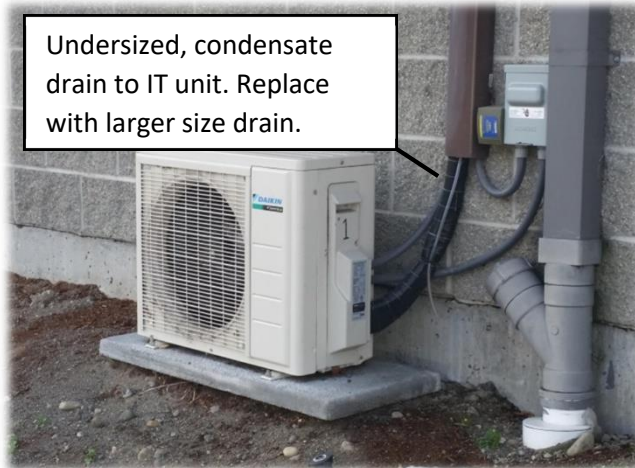
Undersized, condensate drain to IT unit. Replace with larger size drain.

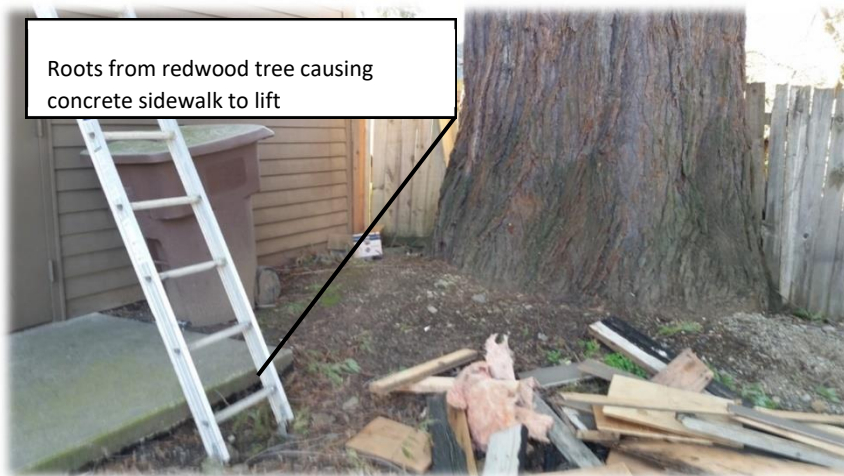
- Asphalt Paving –fair condition
- Parking Shared parking lot with City Hall
- Stormwater – none
- Lighting recessed soffit lighting
- Landscape very large redwood tree near NW building corner. Roots from tree have lifted concrete sidewalk and may damage concrete foundation over time. Large limbs falling from this tree will damage roof and create a life safety hazard.

- Replace all doors, currently they have ¼” gap around all outer doors poor condition
- Contract with a qualified arborist to explore options regarding the large redwood tree growing near the building. The tree roots are lifting the concrete sidewalk and could damage the concrete foundation and electrical service. Falling limbs would damage the new roof membrane and air handlers and present a life safety hazard.

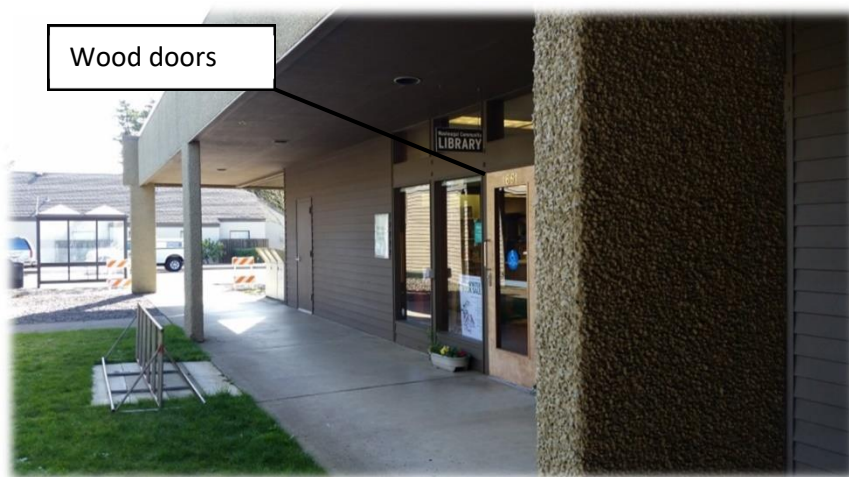
- Floors concrete slab on grade with carpet and vinyl floor coverings
- Community Center flooring was replaced in 2021
- Walls wood frame with painted gypsum board – good condition
- Ceilings suspended acoustical ceiling tile – good condition
- Doors/Hardware wood doors in metal and wood frames – poor condition

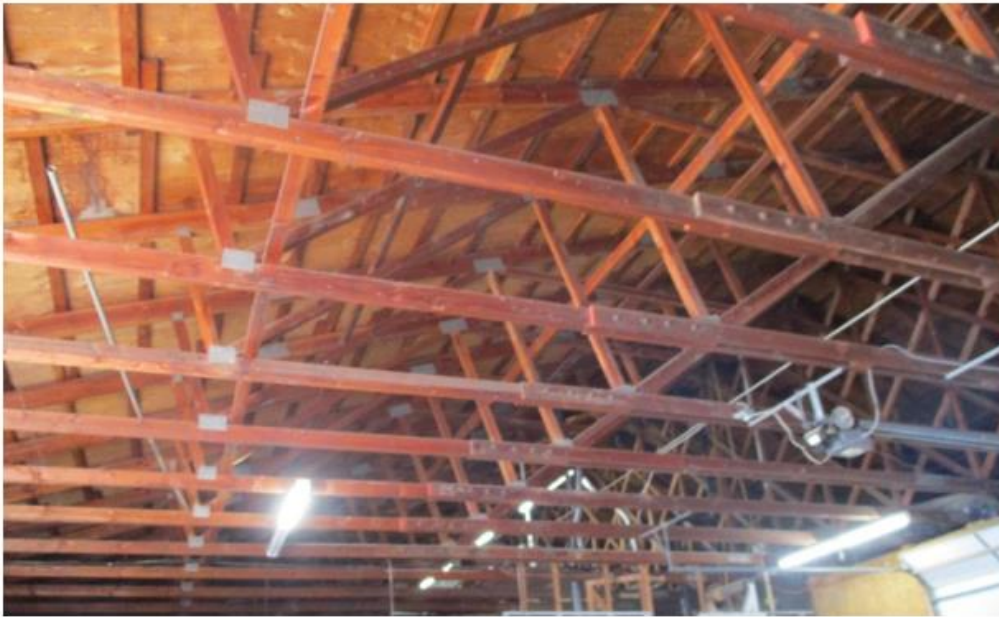
**Figure 2.1. Wood Trusses Supporting Roof**

Building A is an 8,500 square foot structure, constructed with wood post frame (pole barn) type construction. The roof is supported by wood trusses, as shown in [Figure 2.1](#). The majority (approximately 2/3) of the building has had partition walls installed to create office and shop space. These areas have had concrete floors installed. In general, these concrete floors are in fair condition; however, some cracking and damage is noted in the floor at the roll up door on the south side of the building. This is likely due to the rough transition between the asphalt and the concrete, as shown in [Figure 2.2](#) and [Figure 2.3](#).

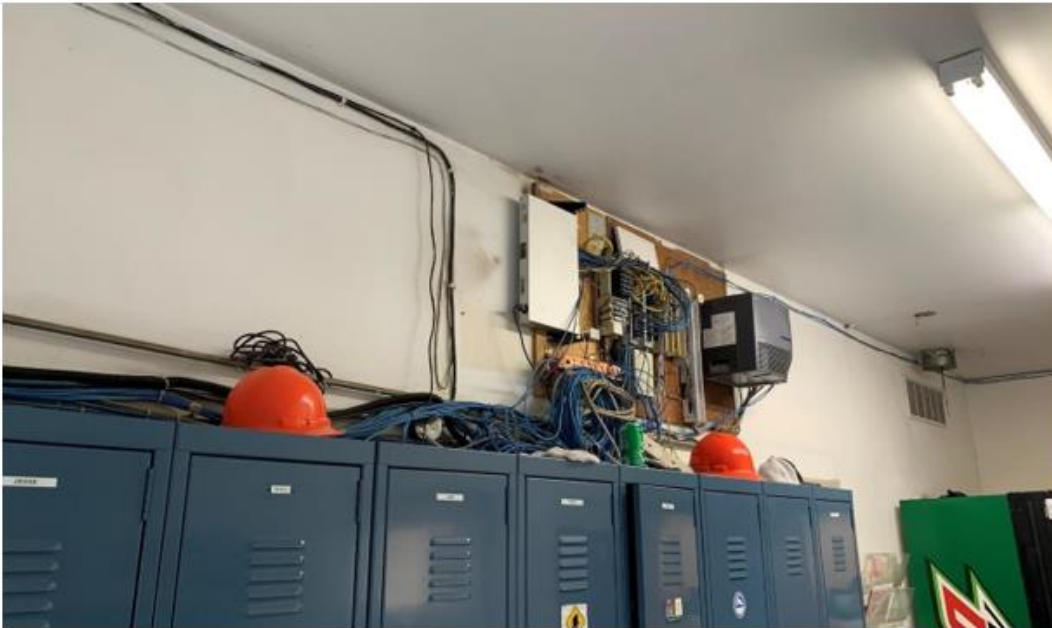
**Figure 3.2. Exposed Communication Equipment**

The building receives an overhead fiber optic communication line from Verizon Communication equipment. It is installed in the lobby above the lockers and is exposed as shown in [Figure 3.2](#) and [Figure 3.3](#). It is recommended that this equipment be installed in a dedicated space, such as a communication closet, or be installed in an enclosure for protection. The communication cables located in the attic space are loosely installed without adequate structural support as shown in [Figure 3.4](#).

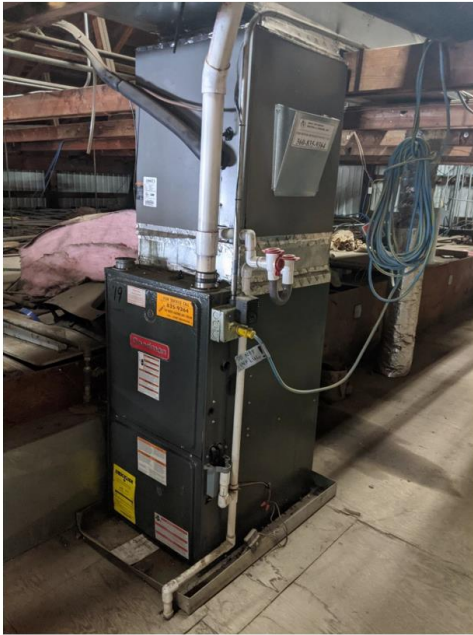
Figure 4.1. Building A Admin Furnace

This area is served by a residential style Goodman natural gas furnace with a 3.5-ton Lennox air conditioner (see [Figure 4.1](#) and [Figure 4.2](#)). The air conditioner was manufactured in 2015; it is unclear when the furnace was manufactured but assumed that it is the same age as the air conditioner and is in fair condition; although, there is a large air leak between the furnace section and the air conditioner coil (see [Figure 4.3](#)) that should be repaired to reclaim some of the system capacity within the occupied

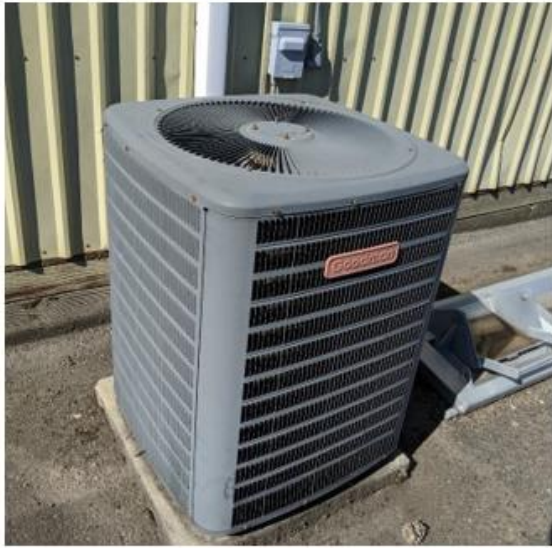
**Figure 4.5. Building A Workshop Heat Pump**

The west side of the building has a mechanic's shop that is served by a second Goodman furnace that has a 3-ton Goodman heat pump from 2007 (see [Figure 4.4](#) and [Figure 4.5](#)). This heat pump is an R-22 unit and while not visibly failing is near the end of its expected service life (15-20 years per ASHRAE) and planning should include replacing this unit soon.

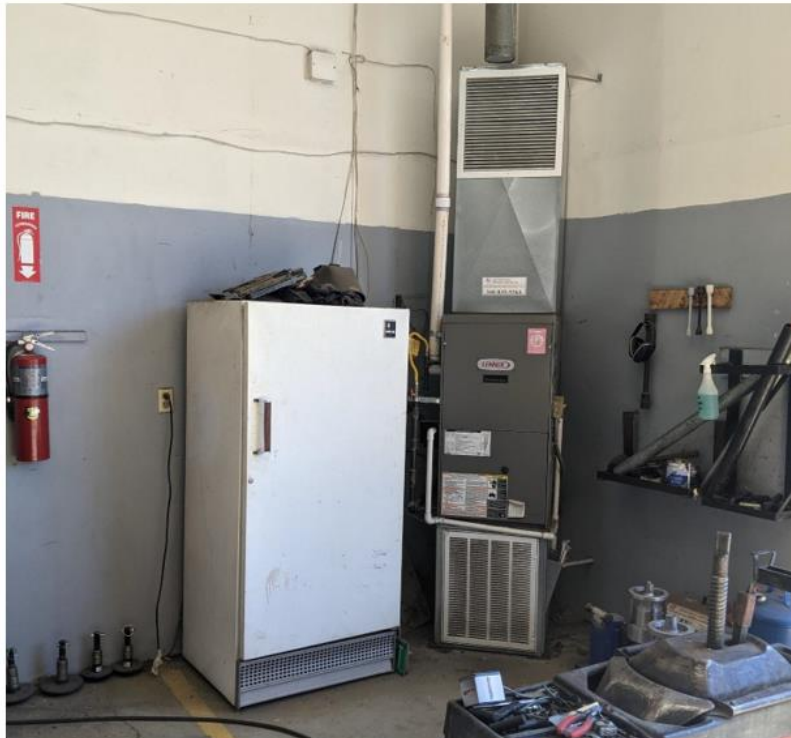
**Figure 4.6. Building A Shop Furnace**

The southwest corner of the building is another shop that also has a small, elevated office and a couple parts storage areas. This shop has a Lennox furnace in the southeast corner. It does not have any cooling capacity (see [Figure 4.6](#)).

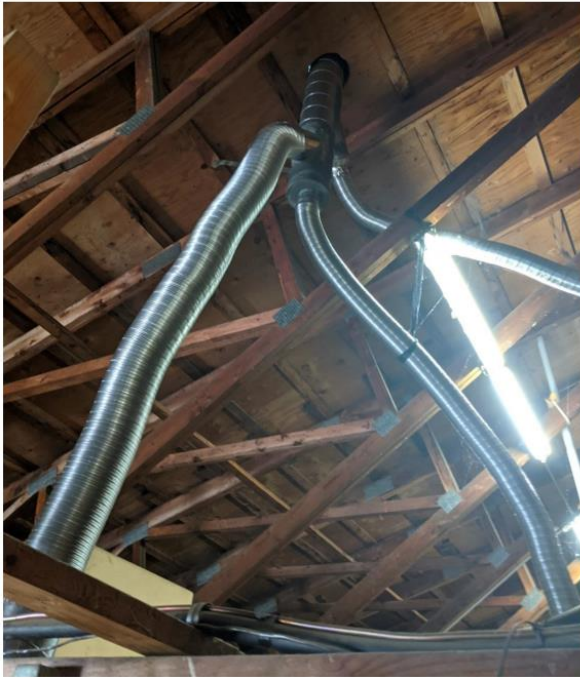
Figure 4.7. Building A Exhaust Connections

There are several exhaust systems connected into a single roof penetration (see [Figure 4.7](#)). None of these ducts are insulated and may have condensation issues since they are in the unheated portion of the building.

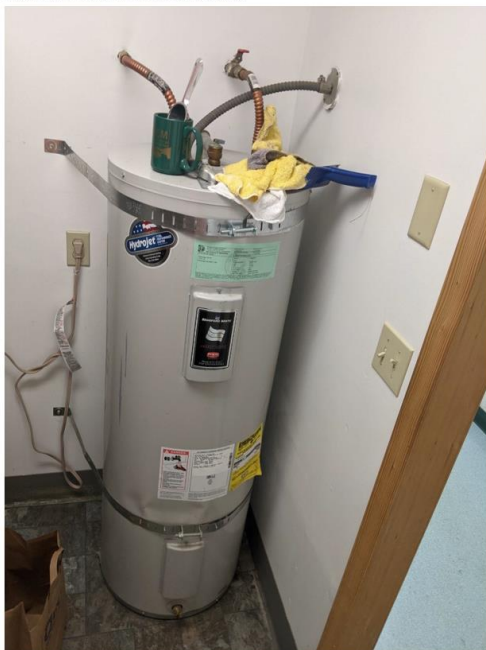
Figure 4.8. Building A Domestic Water Heater

Plumbing is limited to the break room and two restrooms in the administrative area. The restrooms appear to be in good condition and the fixtures were all working. A Bradford White electric domestic water heater from 2005 is in the alcove adjacent to the women's restroom (see [Figure 4.8](#)). This appears to be in working condition but is nearing the end of its expected service life and accommodations for replacement should be considered. There is also an ice maker in this space that appears to be in good working order.

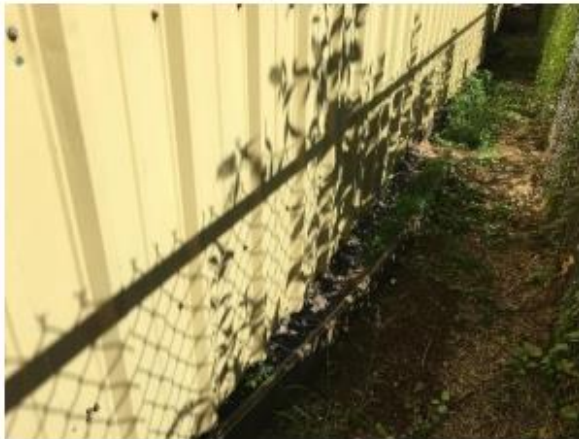
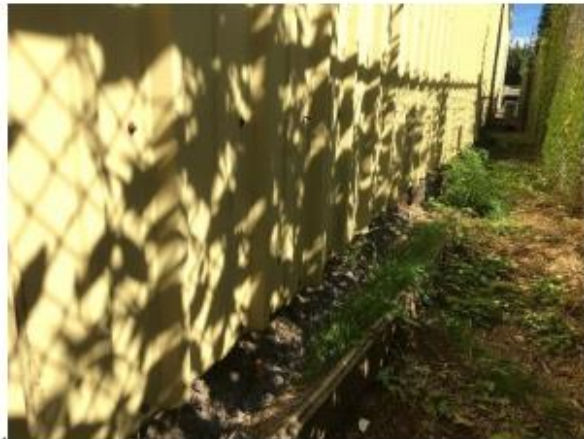
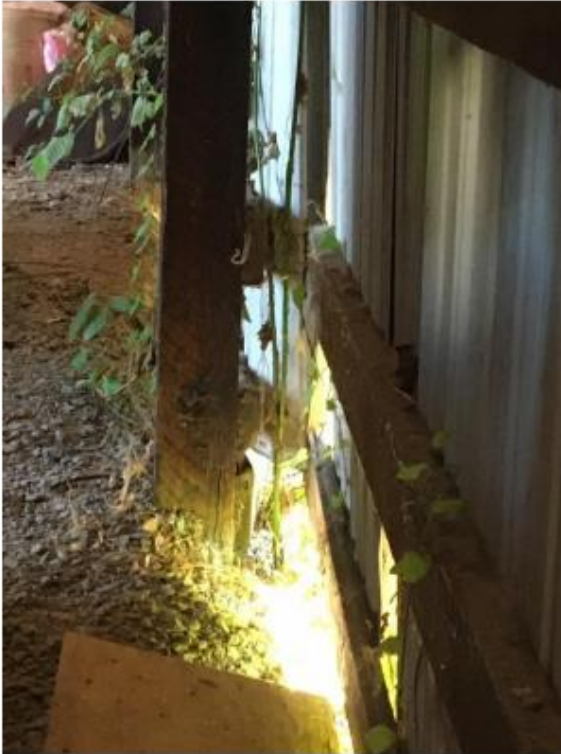
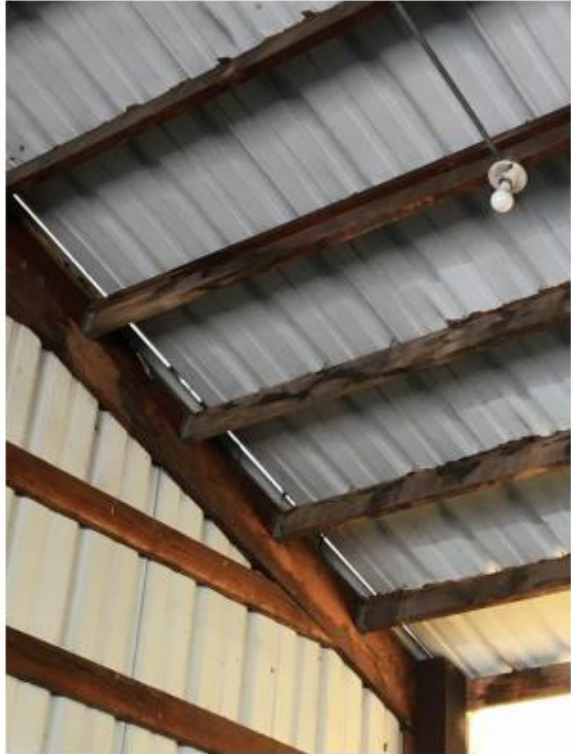
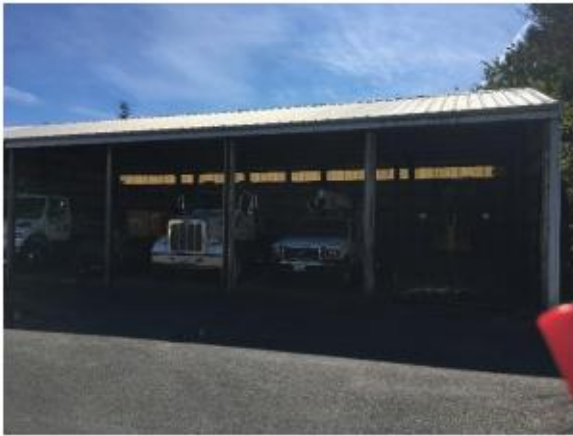
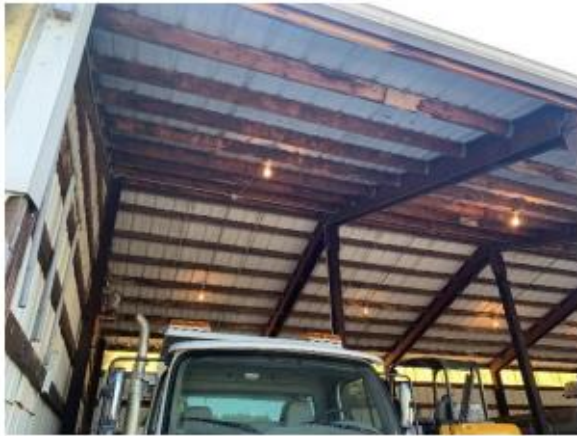
#### **Building B Exterior Photos**

- Metal roof and roof fascia system are in fair condition
- No obvious wear and tear marks on the roof were found
- Detached roof panels are noted near interface with Building C roof
- Leakage from the roof is expected

- Wall exterior condition is below average
- Finish of the wall panels are generally intact
- Multiple dents and locally deformed areas on metal panels are found
- Back wall panels and horizontal wall girts are detached and left opening at the back of the building caused by impact from vehicle
- Aged, corrugated fiberglass wall panels are in fair condition

- Wood fascia and wood blockings that support gutter systems are exposed and unprotected
- Downspouts are functioning
- Water may migrate from the back at the detached wall panels

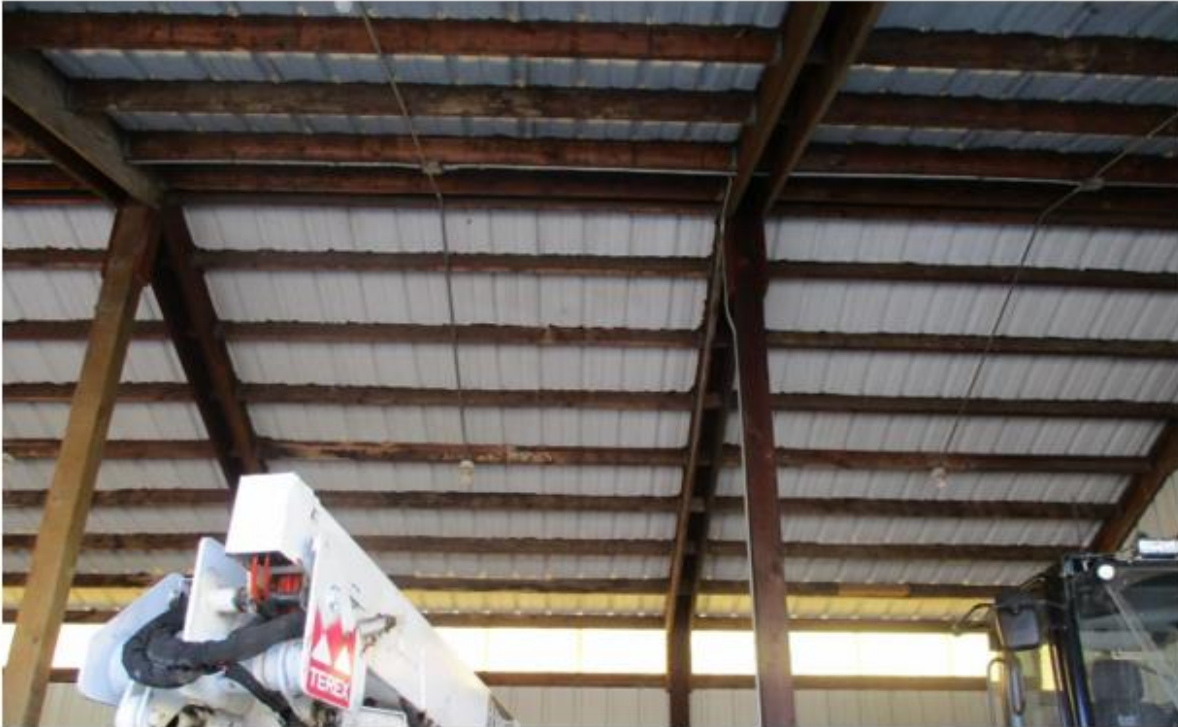
**Figure 2.8. Remnants Between Roof Joints and Metal Roof Decking**

Building B is an open wood post frame building that is used for vehicle storage. The structure is in fair condition. According to City staff on site, the particleboard sheathing was removed due to water damage and decay. Remnants can be seen between the roof joists and the metal roof decking (see [Figure 2.8](#)). This will significantly hamper the structural performance of the roof system during a windstorm or in a seismic event, as there is no structural diaphragm present. Additionally, this causes the roof deck to sit just proud of the joists and leaves a small gap at the edges (see [Figure 2.9](#)). This could allow rain to be blown into the building, however, in general, it appears that the interior stays reasonably dry. Roof joists and most other structural connections appear to have been made using metal timber connectors.

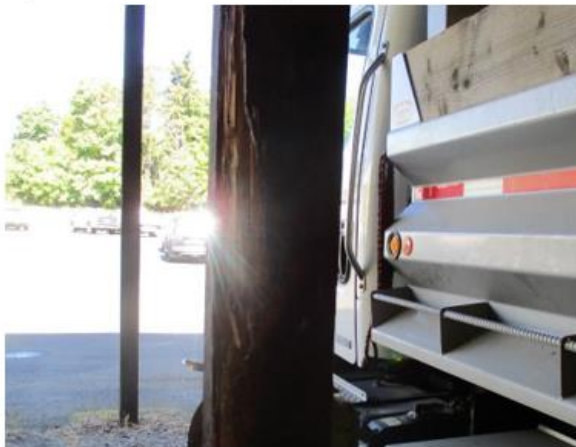
Figure 2.11. Column Damage

One column between the third and fourth bay shows damage due to vehicle impact, as shown in [Figure 2.11](#). No decay was noted in this, or any other, of the columns. Other than the damaged purlins in the third bay, all other purlins appear to be in good condition. No signs of decay are noted in the roof system, however with only the metal roofing to protect the members, the roof system is at a greater risk of getting wet and decaying over time.

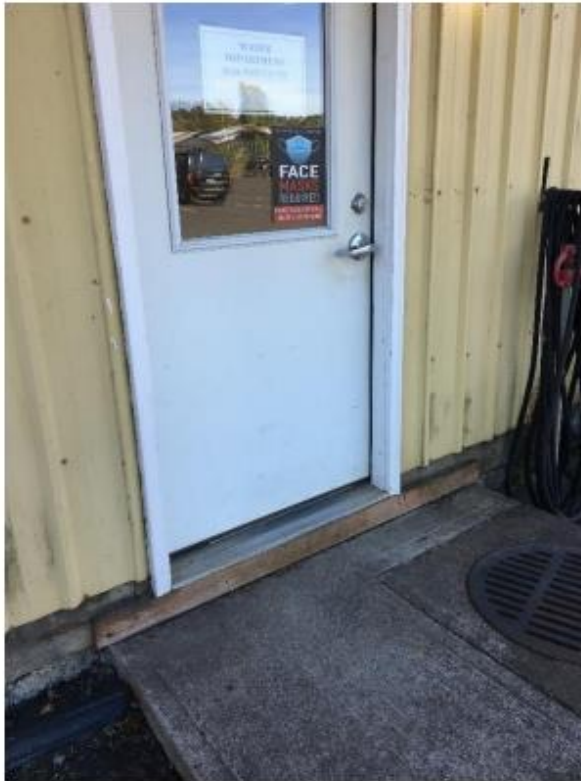
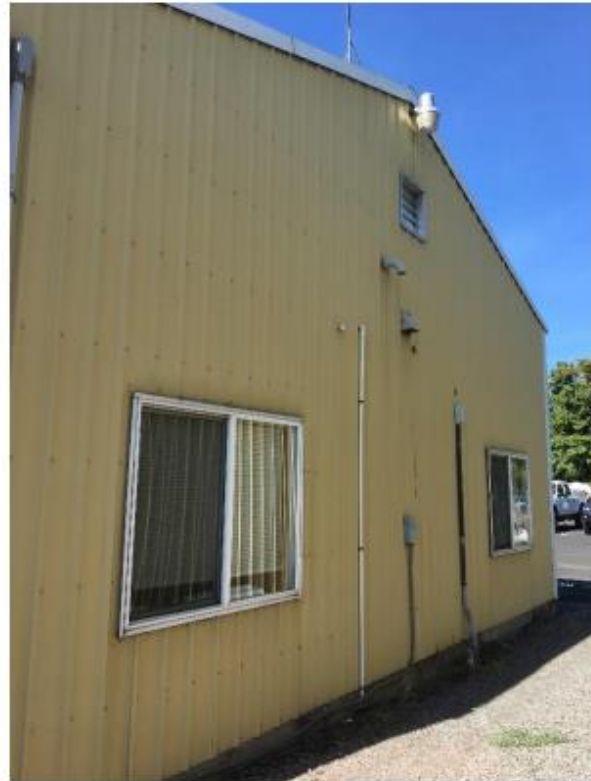
## Building C Exterior Photos

- Wall exterior condition is aged and below average
- Finish of the wall panels are generally intact
- Dents and locally deformed areas on metal panels were
- Treated wood wall curbs are exposed without flashing transition or protection

- Portion of the roof gutters is slightly deformed above the barn door at storage
- Wood fascia and wood blockings that support gutter systems are exposed and unprotected
- Downspouts are functioning
- Downspouts are not tied to the storm drain system and most of them are without splash block
- Oversize metal flashing and trim above vehicle access door to the shop is in fair condition. Metal flashings above windows function but are in poor condition.

- Double pane windows are provided at north and east walls, and they are in fair condition
- Water migration likely occurs at the windows due to poor flashing details. They function but are in bad condition.
- In-swing exterior egress door is not insulated
- Manual uninsulated sliding rolling door at garage is deformed but functioning. It is in poor condition.

The slab under the office space section is exposed at grade and does not have a turndown at the edges, which is required to ensure adequate frost depth (see [Figure 1.8. Building C Exterior Photos](#)). Frost depth at this location is 12 inches. It is likely that this slab was poured after the building was erected and does not work to provide structural support to the building. If frost damage to the slab were to occur, such as heaving, it could lead to damage to the floor finishes and partition walls.

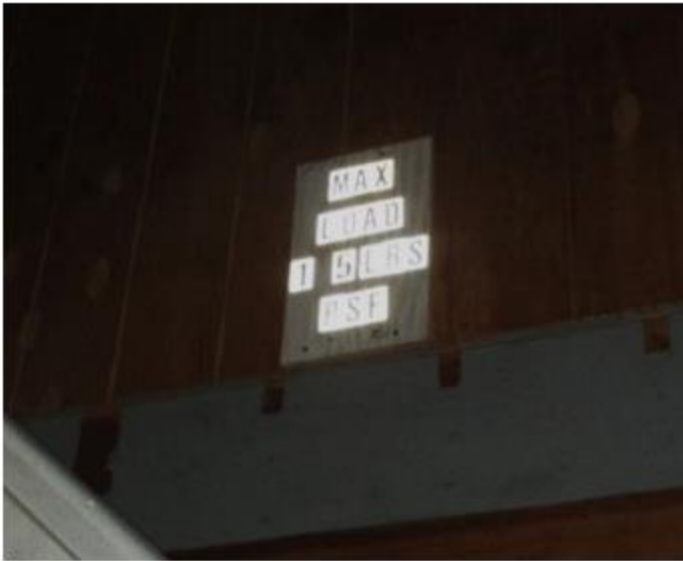
**Figure 2.12. Sign at Top of Stairs**

A sign at the top of the stairs indicates a maximum load limitation of 15 psf for the loft space (see [Figure 2.12](#)). The floor in this area does not exhibit unexpected deflections when walking around. However, the code minimum loading requirement for a habitable attic space such as this is 30 psf. As 15 psf is a value that is very easy to exceed, a thorough evaluation of the items stored in this space and its layout is required to ensure that the design load is not exceeded, particularly where the heavy-duty shelving is located (see [Figure 2.13](#)).

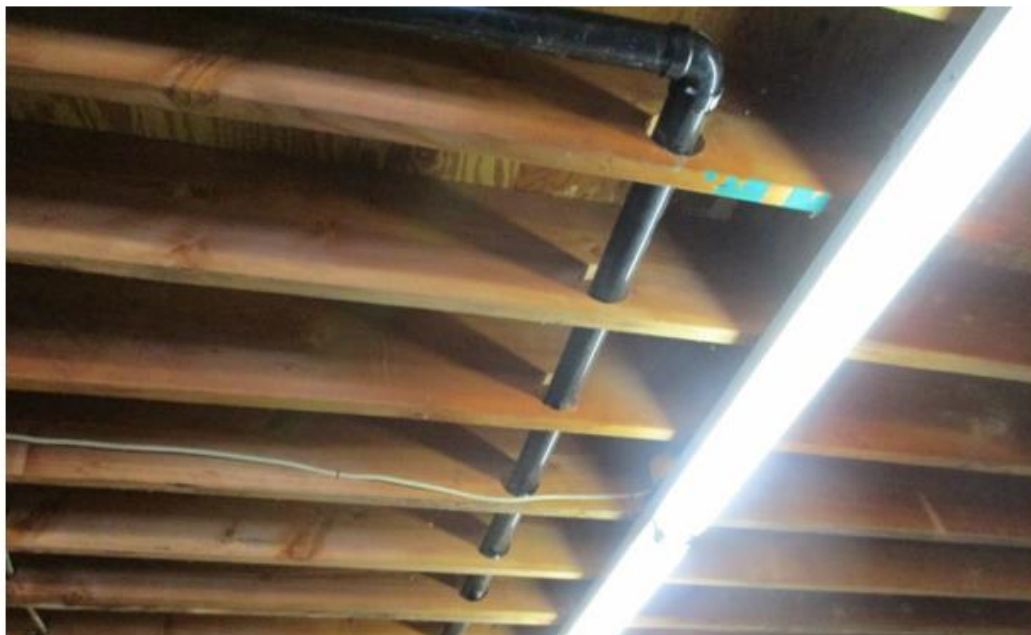
**Figure 2.15. Holes Drilled in Joists**

Most of the structural elements are hidden from view by interior finishes, however, the portions of the structural framing that are visible from the loft area and in the storage area, appear to be in very good condition. The roof sheathing (if present) is hidden by insulation (see [Figure 2.14](#)). The joists supporting the loft area have had holes drilled in them for electrical wiring and plumbing (see [Figure 2.15](#)). These holes do not appear to be placed in compliance with best practices (away from ends, and away from top and bottom edges).

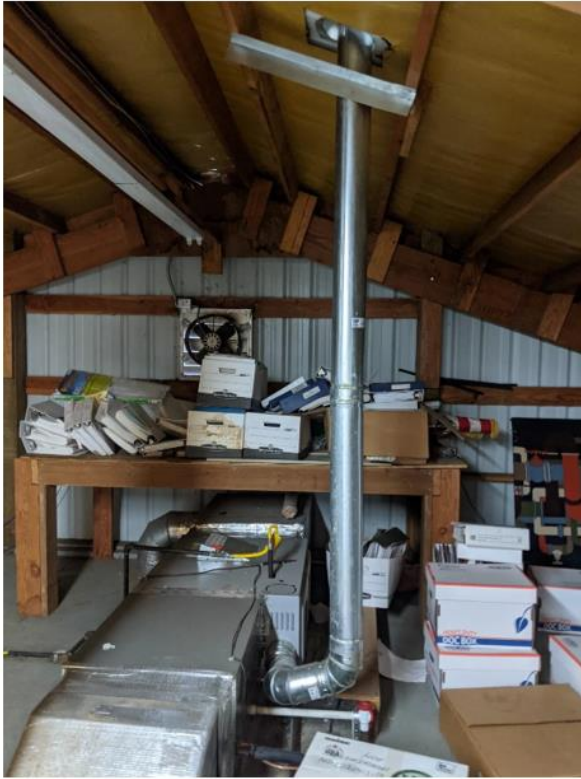
Figure 4.9. Building C Furnace

Building C has an HVAC and plumbing system serving the main level with equipment located in the attic (see [Figure 4.9](#)). A horizontal Lennox furnace is installed on the floor of the attic and an Aire-Flo (Lennox subsidiary) air conditioner is installed at the rear of the building (see [Figure 4.10](#)).

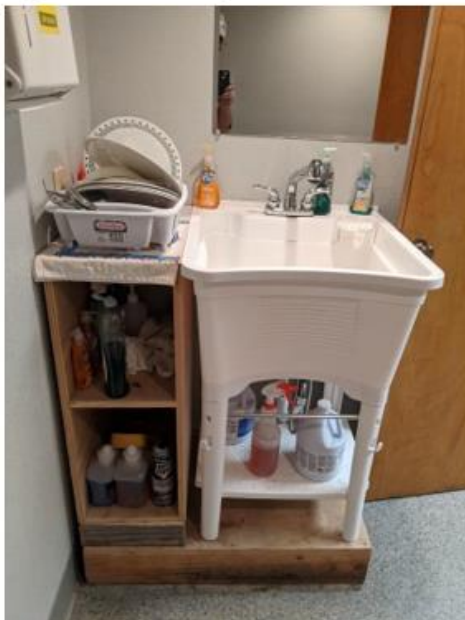
**Figure 4.12. Building C Sink**

The restroom has a shower, water closet, and service sink which is not ADA accessible, (see [Figure 4.11](#), [Figure 4.12](#), and [Figure 4.13](#)). A Bradford White natural gas water heater is in the attic (see [Figure 4.14](#)). This unit is dated 1993 per the Washington LNI Certificate of Inspection. There are signs of previous leaks in the drain pan below the unit and the unit is well beyond the expected life of 10 to 15 years. The plumbing piping was recently modified to serve a partially constructed new room in the back of the building using PEX piping; this new room is not complete and is not in compliance with the current codes. The natural gas meter is in fair condition showing some surface rust.

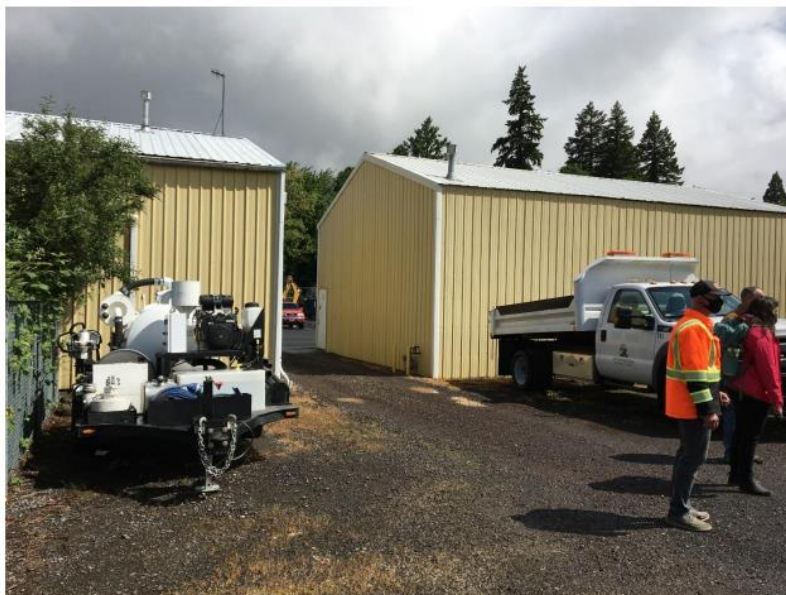
#### **Building D Exterior Photos**

- Wall exterior condition is aged and in fair condition
- Finish of the wall panels are generally intact
- Dents and locally deformed areas on metal panels are found
- Treated wood wall curbs are exposed without flashing transition or protection.

- Manual overhead rolling door in fair condition. They appear to be non-insulated type.
- Metal swing door for egress is in fair condition.

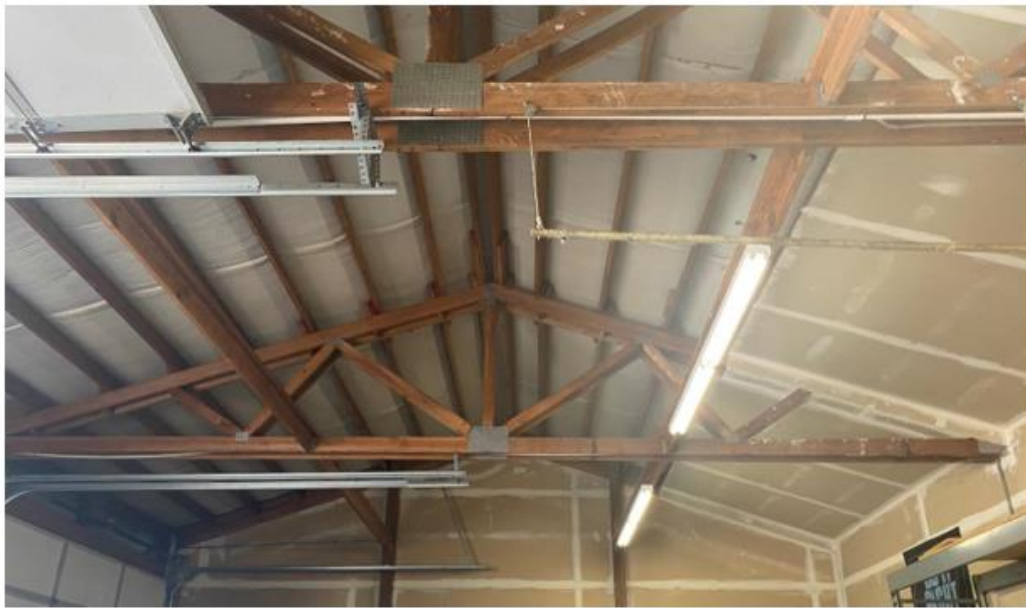
**Figure 2.16. East Timber Trusses**

Building D is a wood post frame building that is primarily used for vehicle storage on the west end and general-purpose storage on the east half. The east and west halves have slightly different roof heights, and it appears that the two portions of the building were built at different times, as the truss designs are similar, but not identical. The west timber trusses are shown in [Figure 2.16](#), with the east trusses are shown in [Figure 2.17](#). It is likely that the east portion of the building is older. Both portions of the building appear to be in good condition. Building posts are constructed from treated timber. No evidence of decay or structural distress is evident. Some minor checking is noted in the columns of the west half.

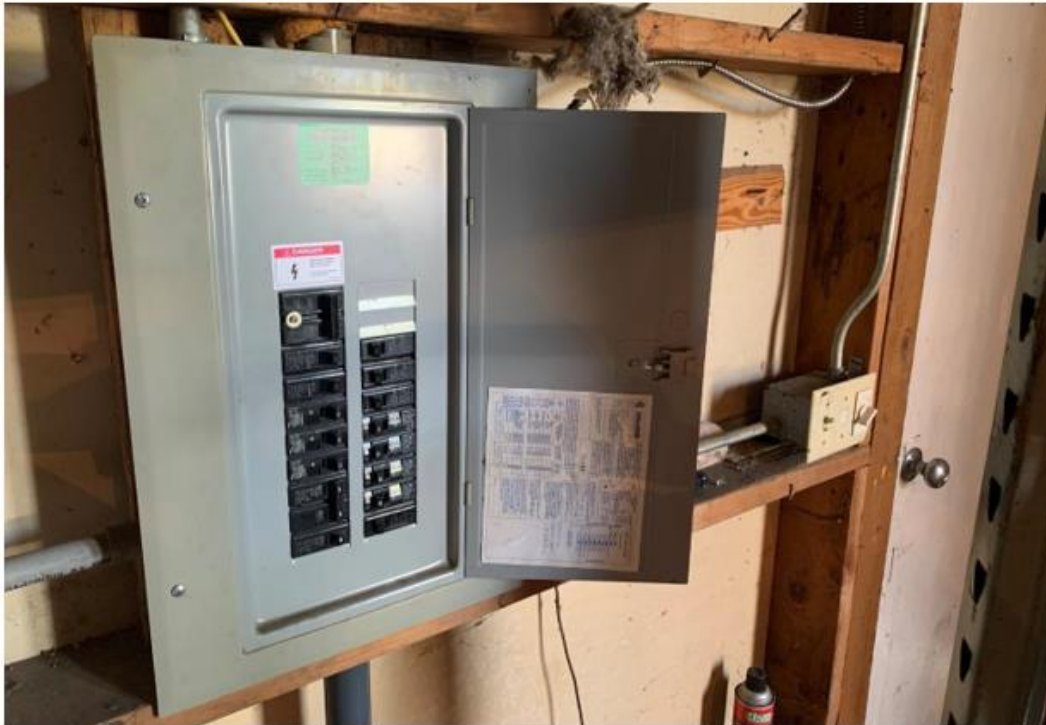
**Figure 3.9. Building D Panel**

Building D is provided with a 120/240-volt, 1-phase, 125-amp electrical sub panel that is fed from a circuit from Building C. The panel is a Challenger load center with 20 spaces, as shown in [Figure 3.9](#), and appears to be in good condition. A large metal shelf is installed in front of the panel, as shown in [Figure 3.10](#), which is in violation of NEC requirements for clear working space in front of electrical equipment. The panelboard circuit directory is missing, which is a violation of NEC requirements.

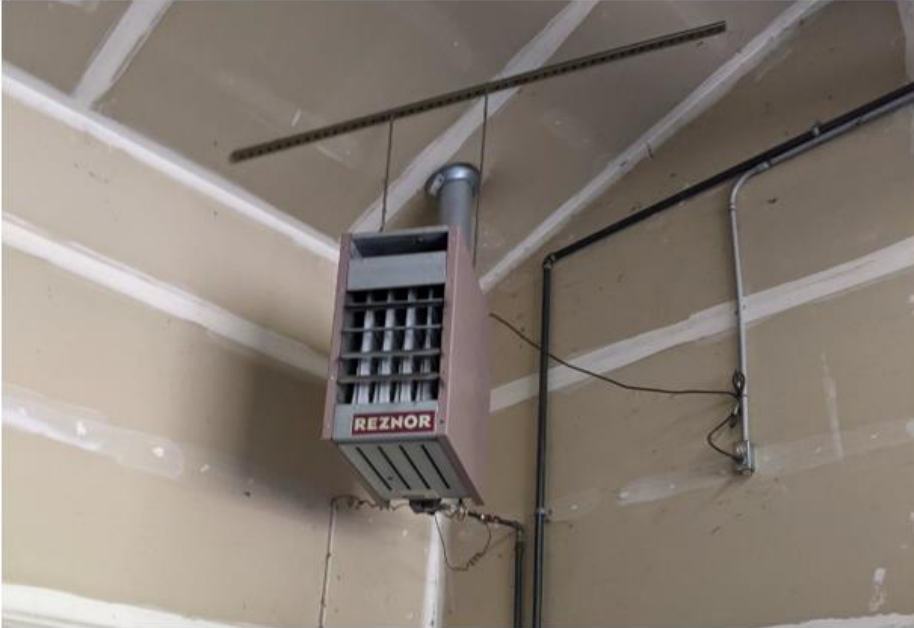
**Figure 4.15. Building D Gas Unit Heater**

The west half of Building D has a single natural gas unit heater located in the southwest corner (see [Figure 4.15](#)). There is no other heating, air conditioning, or ventilation in this building. The natural gas line in this building is extended to the east to serve Building E.

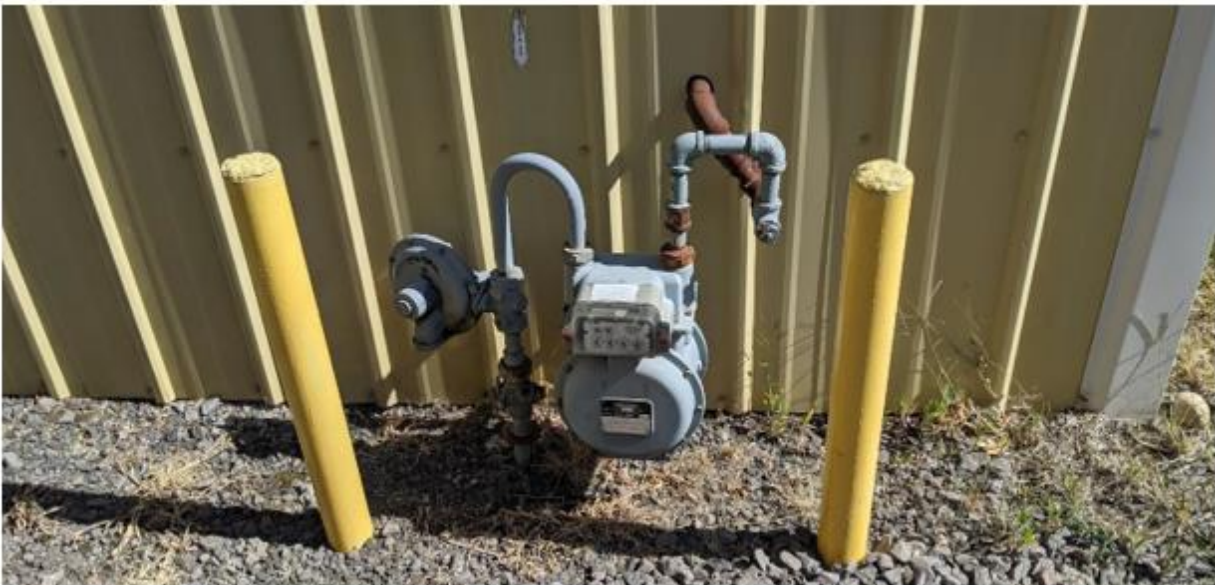
**Figure 4.16. Building D Natural Gas Meter**

The natural gas service is located in the narrow access road between buildings C and D but protected by bollards (see [Figure 4.16](#)).

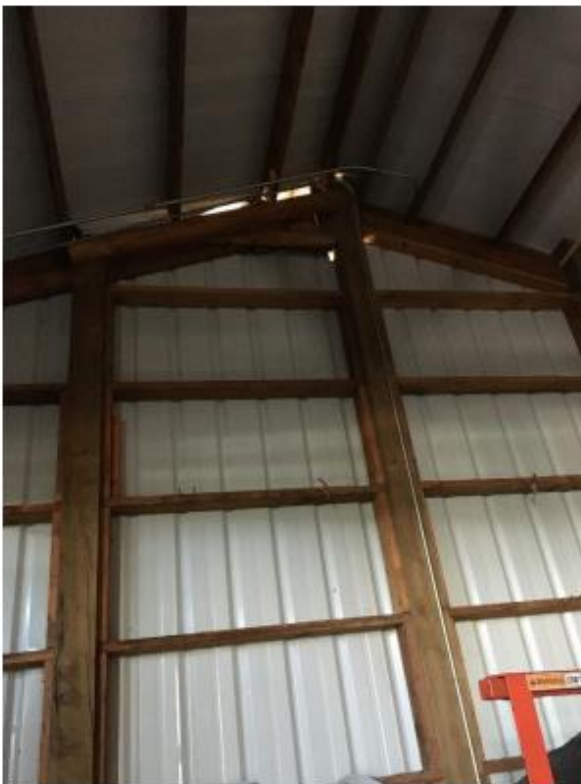
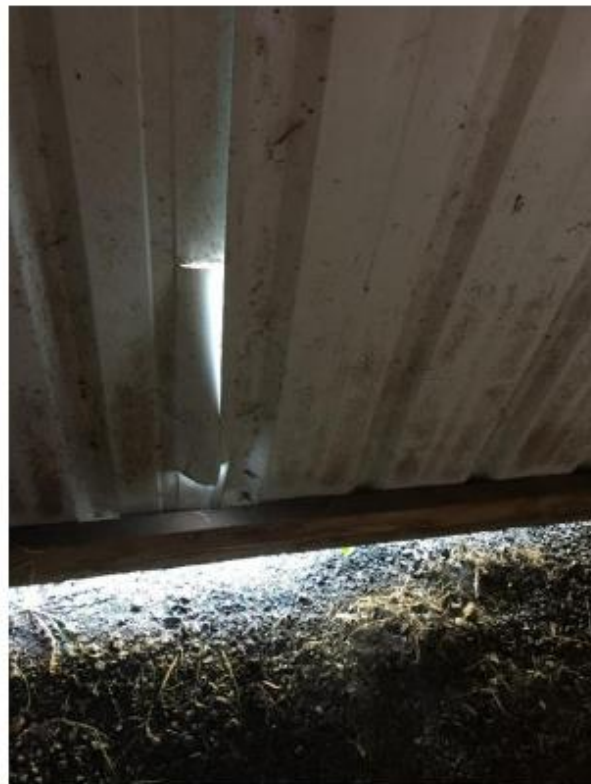
**Building E Exterior Photos – Picture on the right is of Bldg. D**

- Wall exterior condition is aged and in fair condition
- Finish of the wall panels are generally intact
- Dents and locally deformed areas on metal panels were found
- Treated wood wall curbs are exposed without flashing transition or protection

Doors: Manual uninsulated sliding doors at Storage are deformed but functioning. They are in poor condition.

with direct ground contact are not recommended for industrial buildings. Detached roof panels caused by poor workmanship or detail is noted near interface with Building E roof. Leakage from the roof is expected. Deformed wall panels and sliding doors shall be repaired.

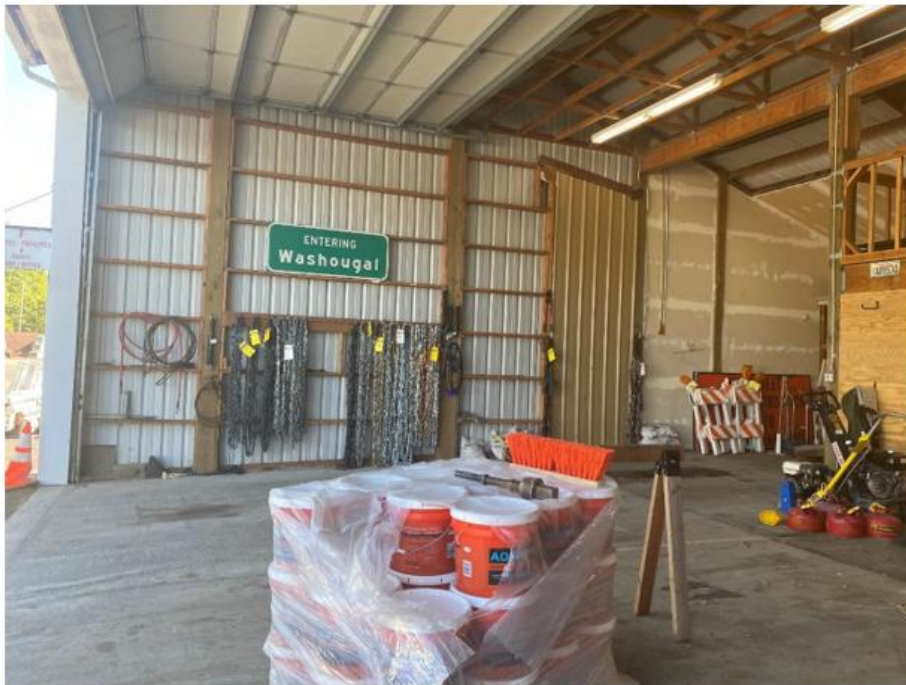
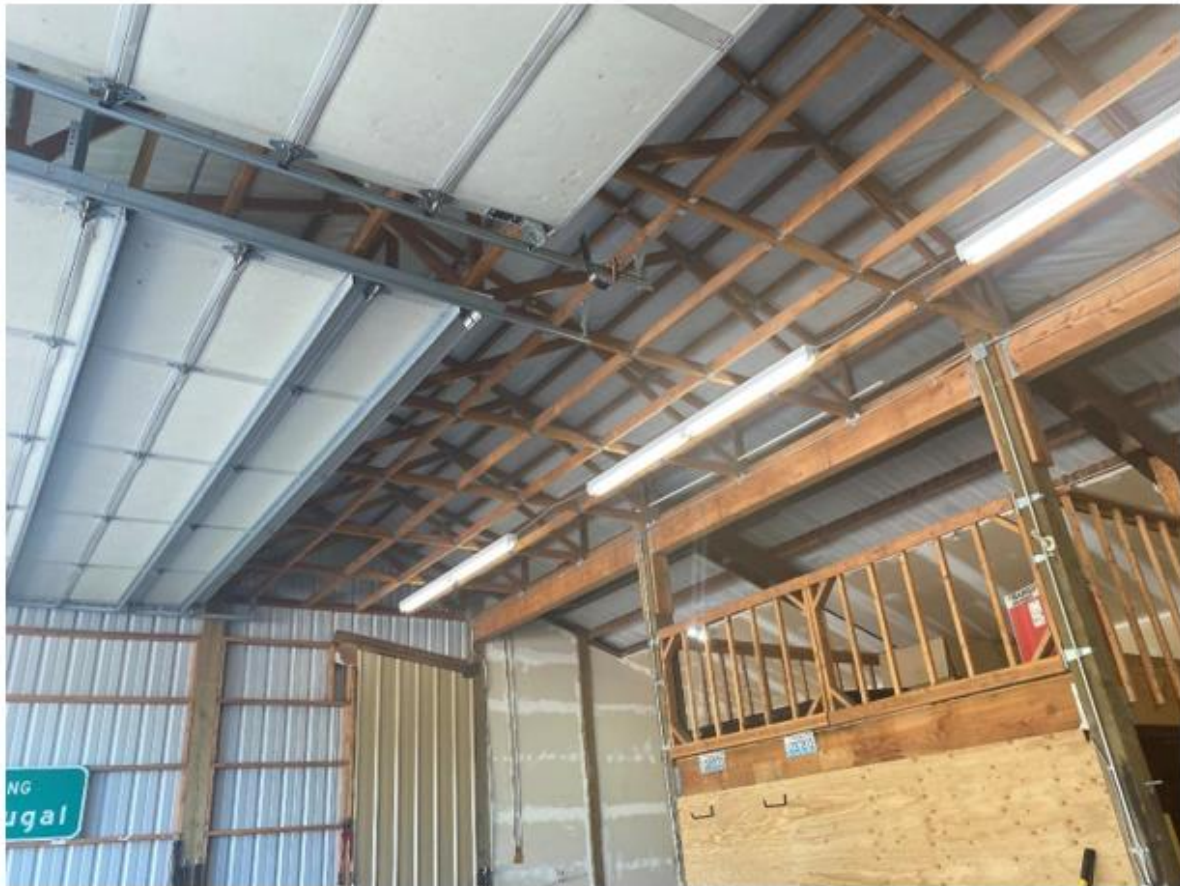
Building E is a wood post frame building that is primarily used for general purpose storage with a concrete floor. It is unknown if the slab meets frost depth requirements. The roof is supported by wood trusses. The west wall is shared with Building D and the east wall is partially shared with Building F. In general, the exposed structure appears to be in good condition. Based on the construction methods used and the coloration of the treated timber elements, it appears this structure is one of the newer structures on the site. Photos are shown in [Figure 2.18](#) and [Figure 2.19](#).

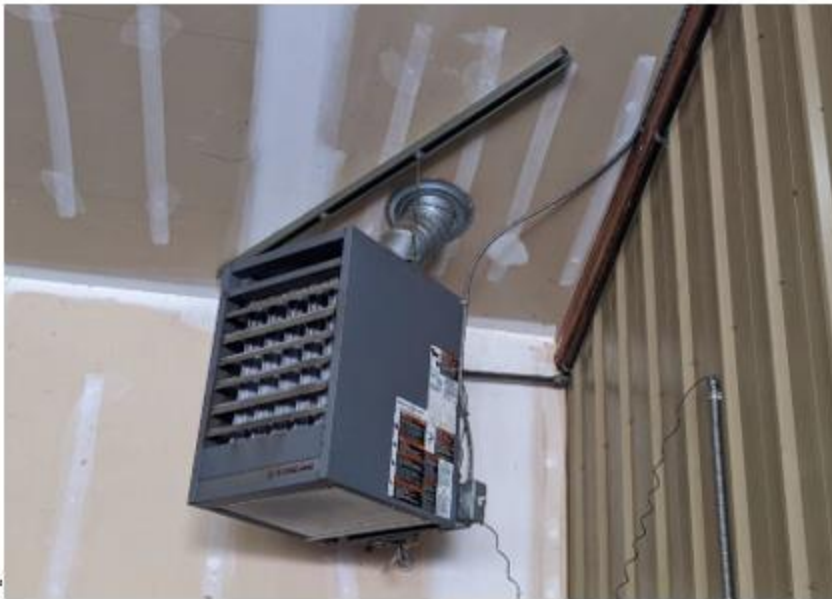
**Figure 4.17. Building E Unit Heater**

Building E has a single unit heater in the southwest corner, fed by natural gas from Building D (see [Figure 4.17](#)). The thermostat for this unit has been disassembled and may not be functioning (see [Figure 4.18](#)). There are visible gaps around the perimeter of this space, most noticeably at the joint between Building D and Building E that allow air and water to infiltrate the building. These gaps should be repaired to maximize heating system efficiency.
